STAGE 1 ROAD SAFETY AUDIT
Proposed Controlled Crossing Facilities
Marcham Road and Ock Street, Abingdon

Prepared for: Vale of White Horse District Council
Issue 1: 21 March 2014
Ref: TR8140418/GT/001

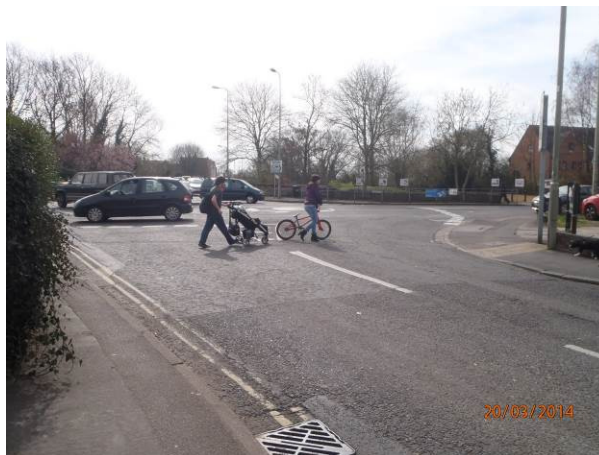
Photograph 1 - Three pedestrians, one of which was pushing a pushchair were observed crossing Spring Road via the existing uncontrolled crossing facility.

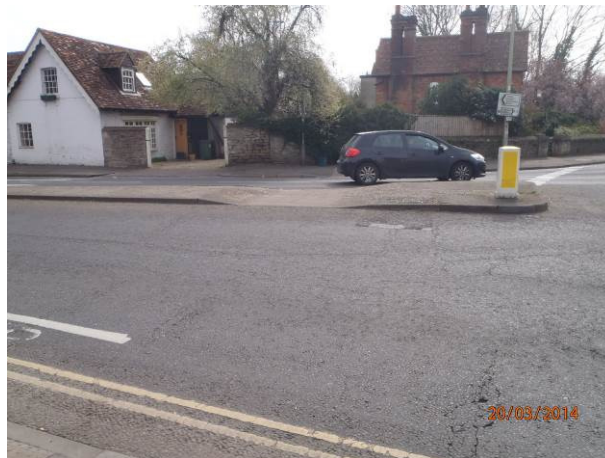
The signalled crossing facility, re-sited east of the junction, requires pedestrians walking between Drayton Road and Spring Road to use the east side of both roads, which, for the majority, departs from their natural desire line on the west side. There is concern that, rather than divert even further to use the signalled crossing facility, significant numbers of such pedestrians will attempt to cross Ock Street on the direct desire line via the central splitter island.

Photograph 2: Splitter island on Ock Street approach

Recommendation: The footway width is insufficient to allow pedestrian guardrailling to be provided.
Discourage pedestrians between Drayton Road and Spring Road from using the east side of by providing more attractive crossing provision on natural desire line on west side.

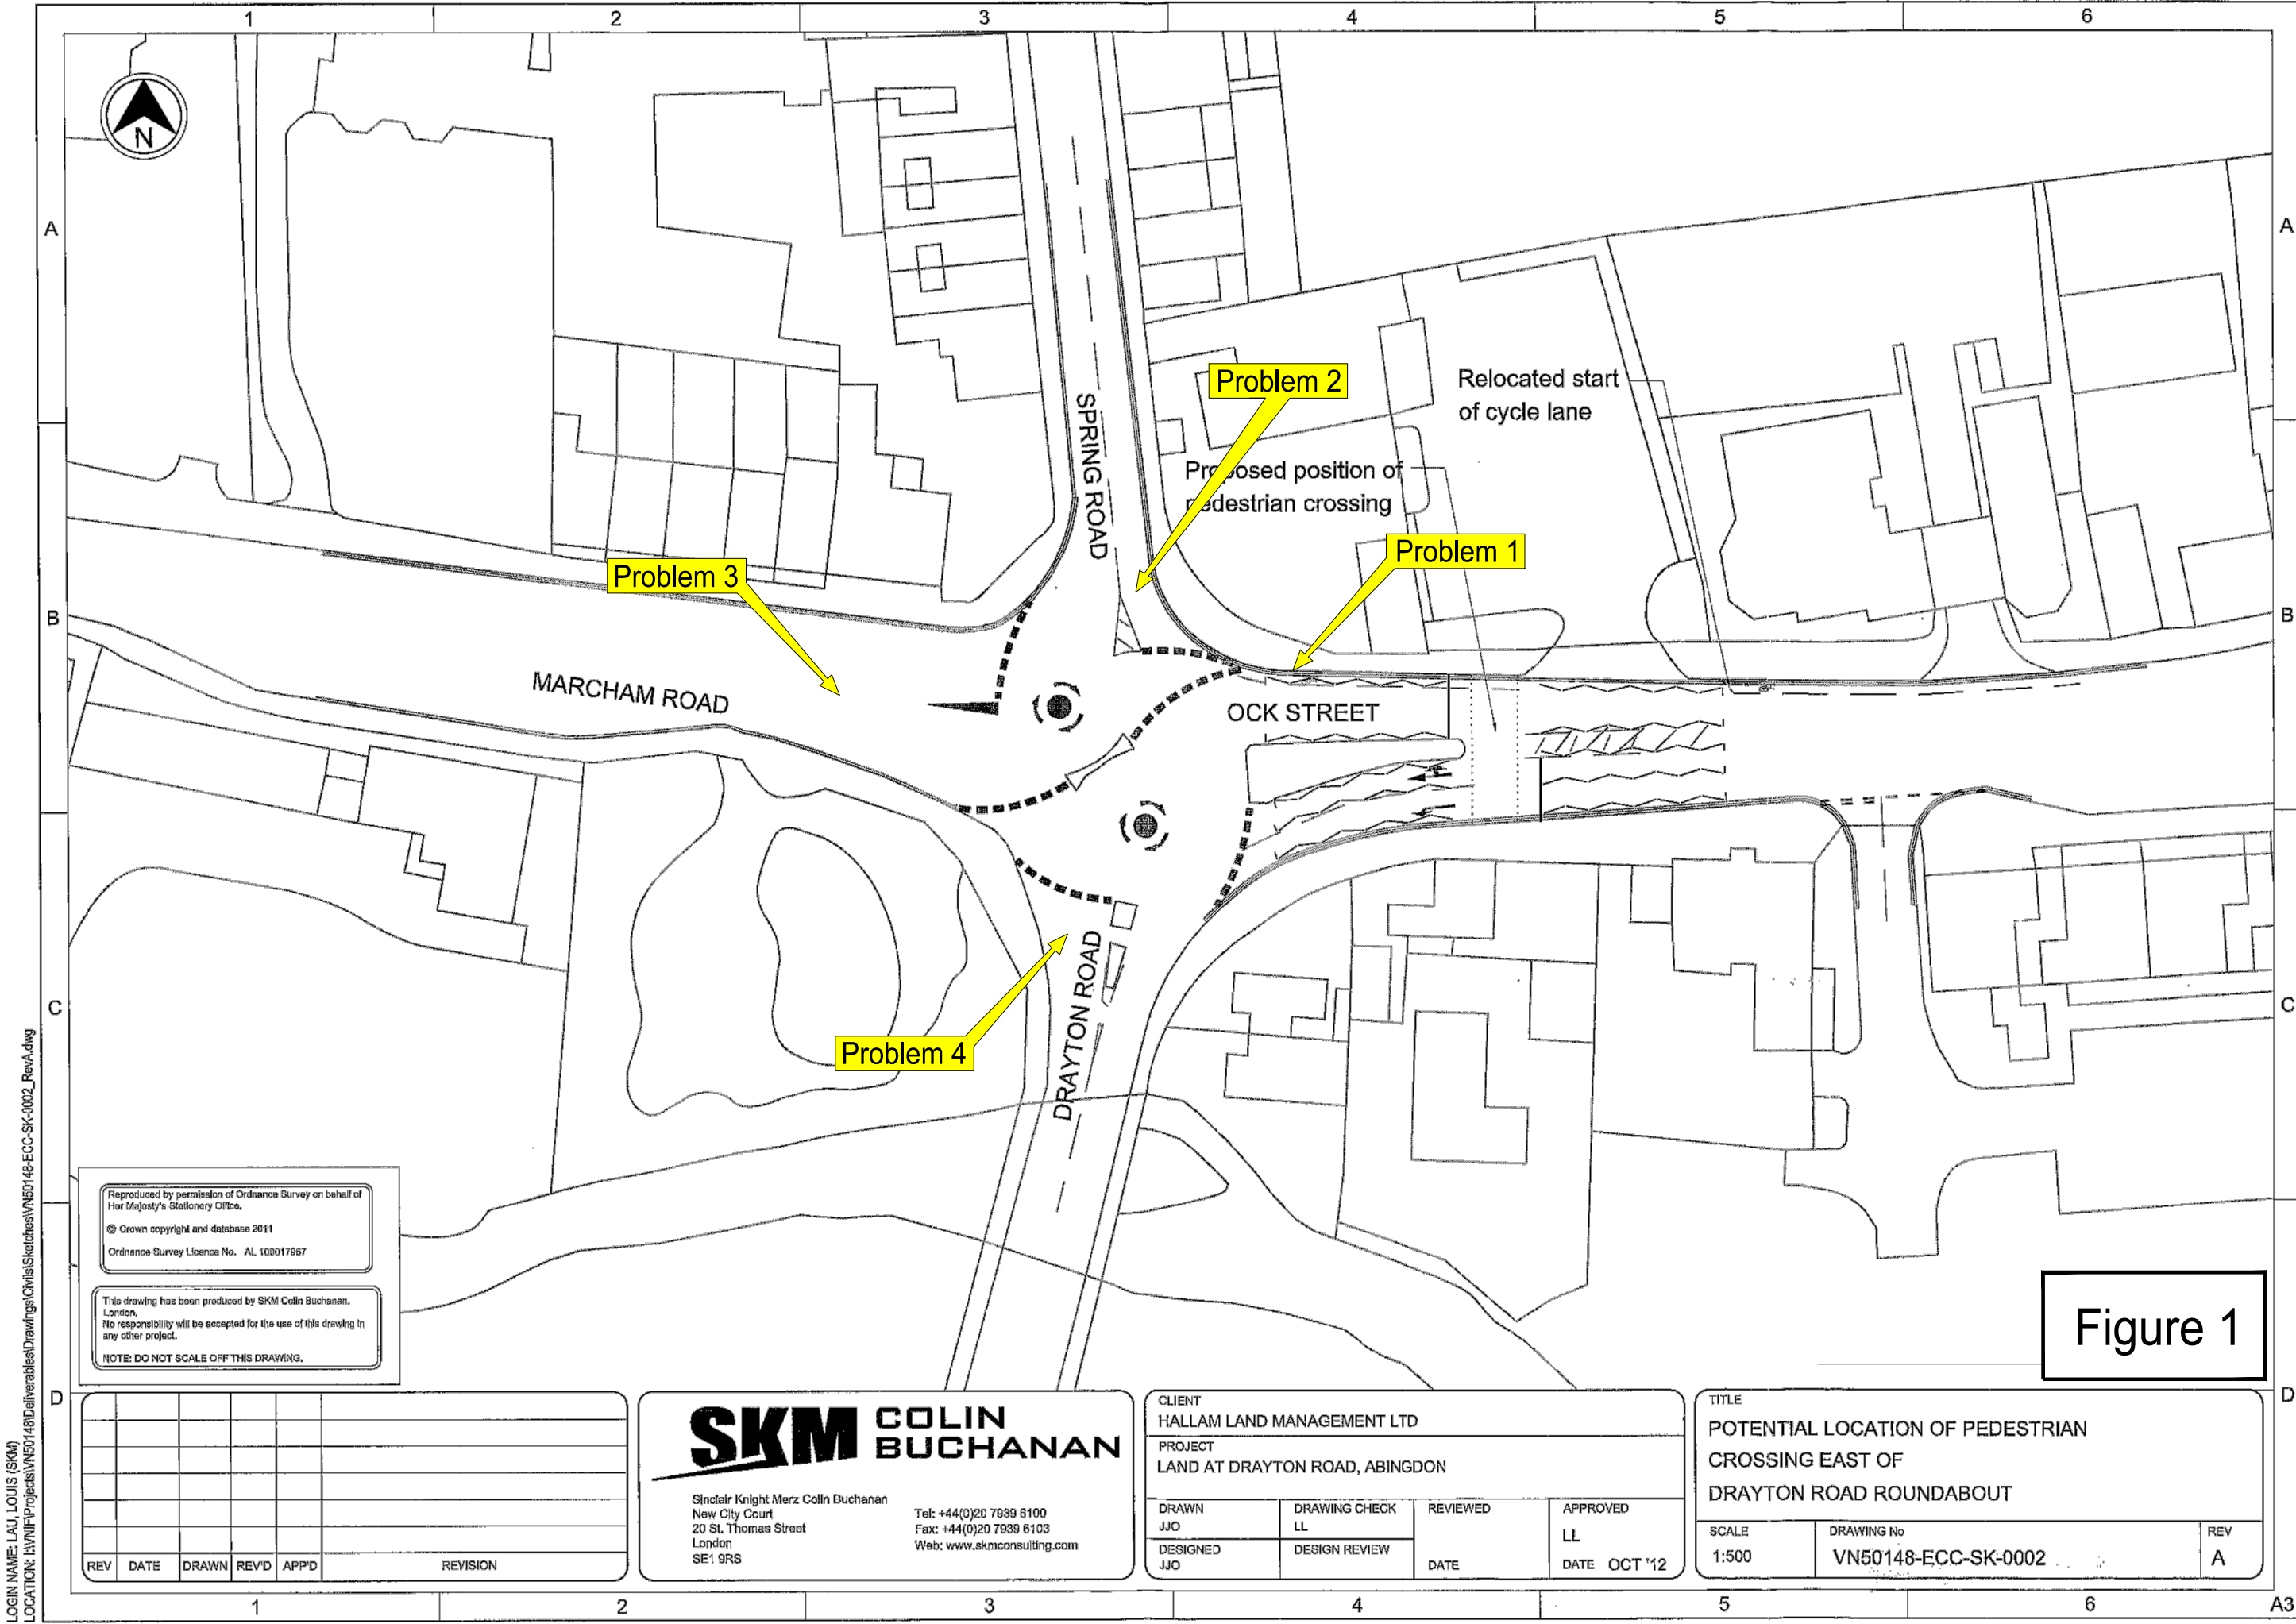
Figure 1

Summary: Pedestrians crossing away from signalled facility leading to risk of pedestrian / vehicle collisions involving personal injury occurring.

Summary: Increased use of uncontrolled crossing facility across Spring Road near the junction, with poor visibility and insufficient footway width, leading to increased risk of pedestrian / vehicle collisions involving personal injury occurring.

Summary: Increased use of uncontrolled crossing facility across Drayton Road near the junction, leading to increased risk of pedestrian / vehicle collisions involving personal injury occurring.

Recommendation: There is insufficient space to widen the footway close to the junction.
Notwithstanding sub-standard footway width, provide appropriate formal crossing facilities at a suitable location on Spring Road remote from the junction, or discourage pedestrians between Drayton Road and Spring Road from crossing to the east side of by providing more attractive crossing provision on natural desire line on west side.

Recommendation: Provision of pedestrian guardrailing on the north side is not recommended as to be effective this would need to extend as far as the crossing and commensurate extension of guardrailing on the south side would need to include a parking lay-by, rendering it unusable.

Discourage pedestrians between Drayton Road and Spring Road from crossing to the east side of by providing more attractive crossing provision on natural desire line on west side.

Recommendation: Discourage pedestrians walking between Drayton Road and Spring Road from crossing to the east side of by providing more attractive crossing provision of Marcham Road on natural desire line on west side.
