OXFORD UNIVERSITY HOSPITALS NHS FOUNDATION TRUST

Horton Hospital Condition Survey

Ref: R/1986.02
March 2017

GKK Transformation

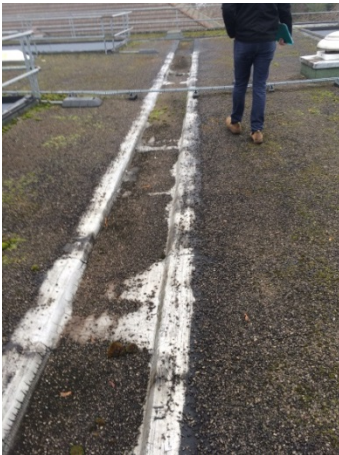
Main Spine Corridor Roof

The exceptions to this are the flat roofs to the Maternity Block (30), the flat roofs above the main link corridor where they have not already been replaced, the asbestos sheet roof to Central stores area (25) and pitched roof to the former gatehouse(5). The flat roofs to the older former wards vary in their condition but are all subject to patch repairs (11,12,13,14,16&19)

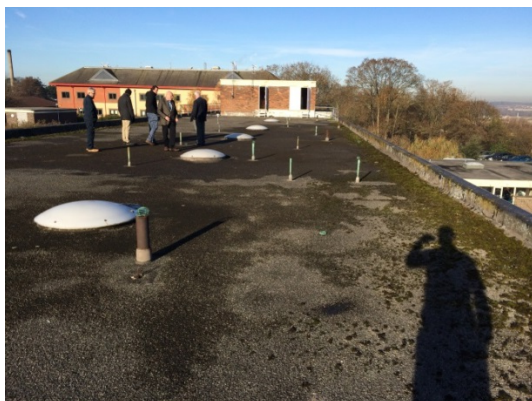
Main Maternity Roof

The Maternity Block has 3 main areas of flat roof, all of which are showing signs of deterioration due to the age of the buildings and having had patch repairs done to leaks in the past.

The main flat roof needs to be renewed within the next 3 years and lightweight roofing lights taken out and roofed over to remove the associated risks of people falling through them.

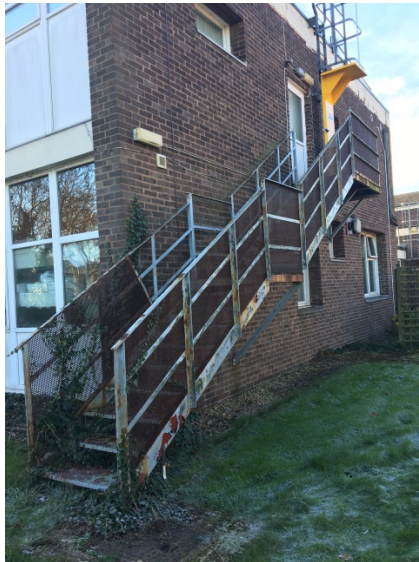
Unprotected External Fire Escape Stair

Access to the roof areas are by the external fire escape and then vertical ladders which are secured by gates kept locked.

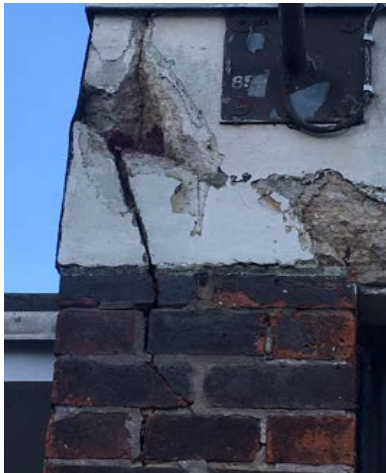
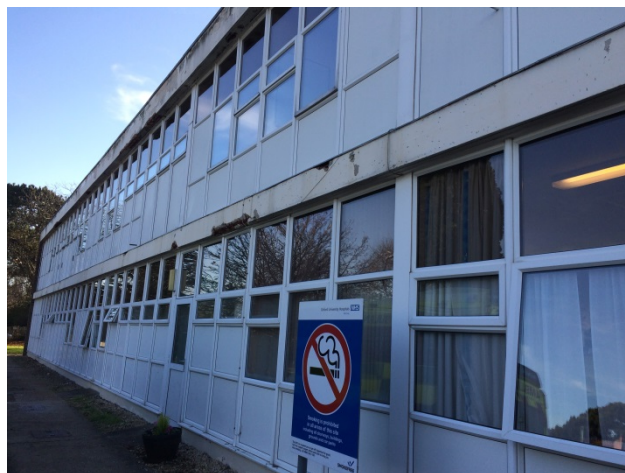
Maternity Elevation

The concrete framed building suffers from spalling to the fascia and soffit panels where insufficient concrete cover to the reinforcement bars occurs. The Trust estates team have carried out the requisite structural surveys and raked off any loose material and treated the steelwork that is exposed to prevent further corrosion. Nonetheless, this is an ongoing problem and results in the building looking very unsightly. The first floor soffits represent a potential risk to passing pedestrians from falling debris although this is minimised by rigorous inspection by the estates team. Any future use of the 50 year old building should allow for these areas to be fully stripped back, cleaned and re-clad or re-rendered and decorated as a minimum.

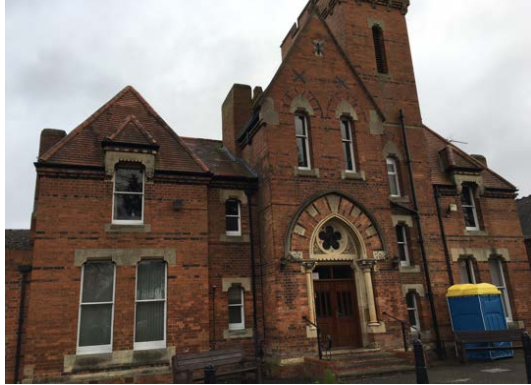
The Victorian Buildings to the south frontage of the site date from an earlier period, 1862-1882, but are of better architectural quality than the 1940's structures. The Hospital borders a Conservation area and it is likely that the core of these buildings will need to be retained. They are not suitable for any clinical care functions.

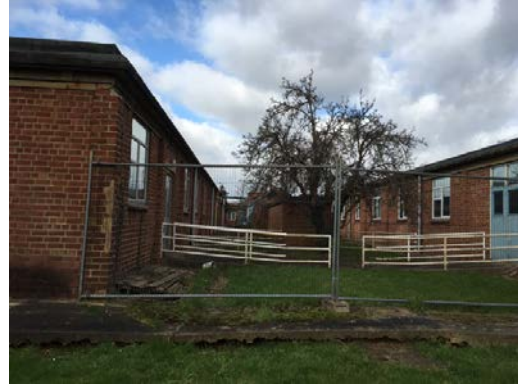
1942 Buildings

The older 1942 single brick wall structures with flat roofs are all beyond their life expectancy. The buildings vary in condition and are occupied by administrative and support functions. These buildings are not worth investing in and should be planned to be replaced over the next 3 years.

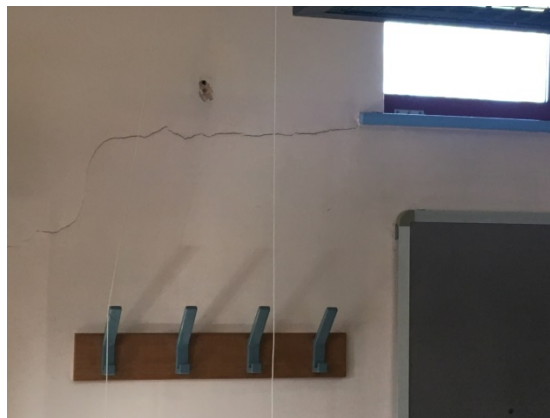
The first floor gable end has several cracks. These may have been caused by the building settling after the extension was built to the Children's ward below. Further inspection/investigation is required to check the stability and that it is not progressive.

Crack to Gable Wall, Therapy Department

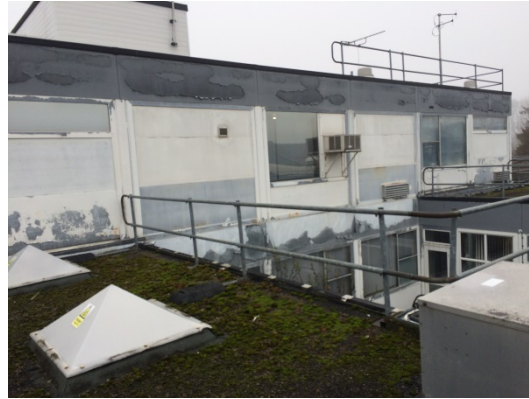
Oxford Building Cladding

Cladding panels showing signs of de-lamination of coating and peeling, particularly at low level. Immediate action is needed to treat and re-protect. In the longer term the buildings could be re-clad.

(Blocks;36,32,41,37,25)

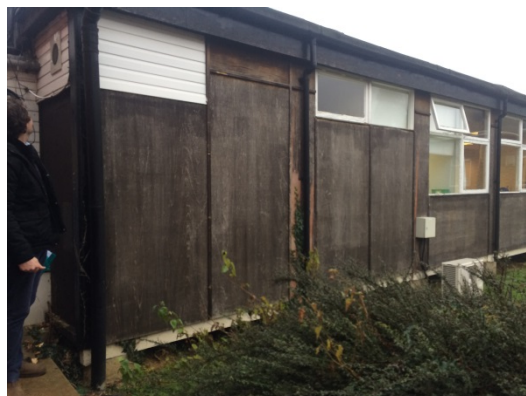
There only a few of these type of buildings on the site. The OPD Portacabin is in very poor condition and at the end of its life. It should be decommissioned and removed from site.

OPD Portacabin in Poor Repair

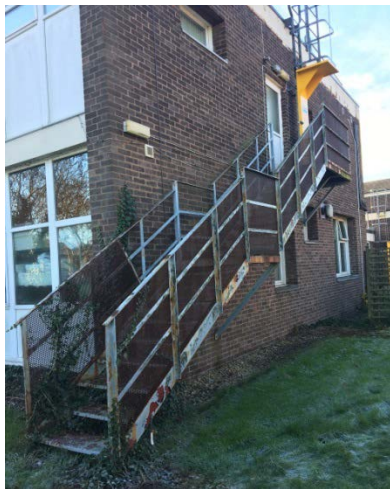
Maternity external fire escape

The survey did identify external fire-escape stairs that were not protected, some escape routes clogged with leaves and one adjacent to the Pathology block that was locked. It was also noted that fire doors in several places were aged and/or damaged. Backlog items have been included in the investment figures

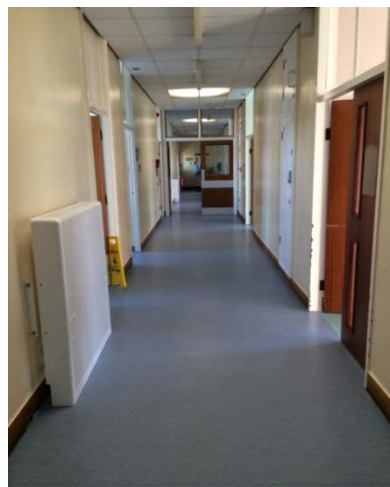
Fire doors requiring replacement

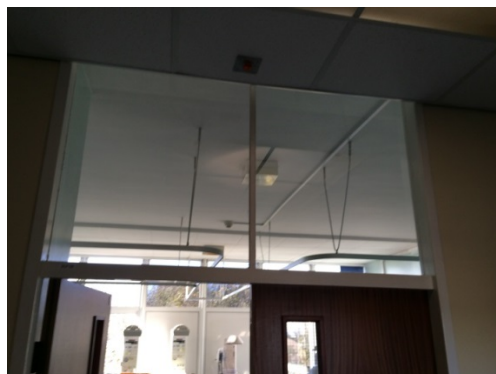
Integrity between door and overhead glass panel

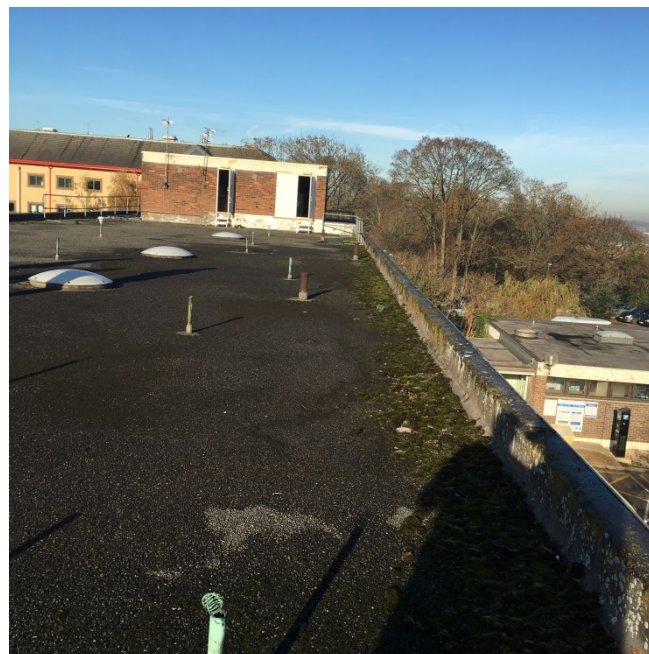
Maternity Roof and Roof Lights

Lightweight roof lights to Pathology and Maternity flat roof areas should be removed and appropriately roofed over or upgraded to required standards.

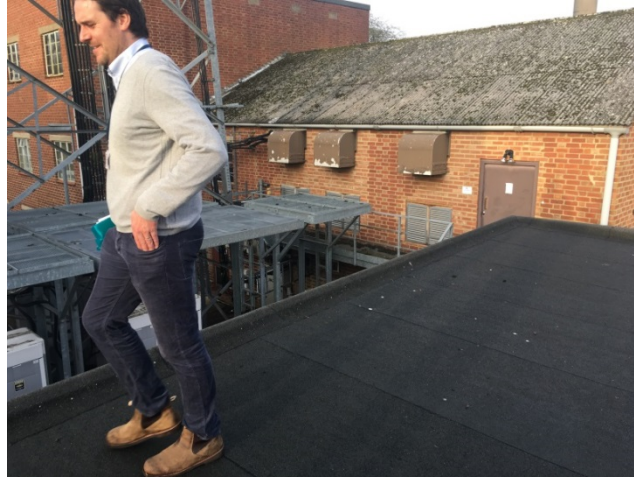
Roof protection is generally well provided although the escape stair from the main spine roof near Pathology requires roof protection as a matter of urgency.

Lack of Edge Protection

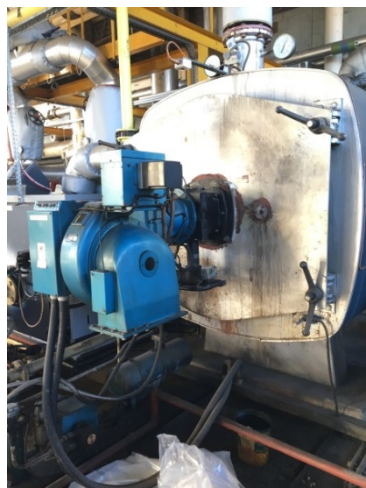
The energy centre provided low pressure hot water from four boilers. Three are relatively new and do not require any investment other than routine maintenance for the foreseeable future. The fourth boiler is approaching the end of its life and a replacement should be planned. Advantage can also be taken at the same time to remove the now ageing chimney structure which will not be required for modern plant using ultra low sulphur fuel.

The boilers provide a single heat source for a site wide constant temperature heating system. This system originally fed a number of blending stations in order to modulate the heating flow temperatures depending on heat demand. The majority of these blending stations are now not in use and require replacement.

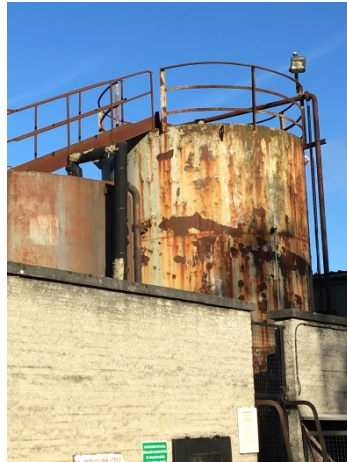
The two oil storage tanks are showing signs of advanced external and internal corrosion. The two tanks have both been decommissioned and vented and there is now only one tank in use the remaining tank should be removed from site (£55k estimate) and consideration be given to providing a small reserve tank to enable maintenance to be carried out to the remaining tank (£25k estimate).

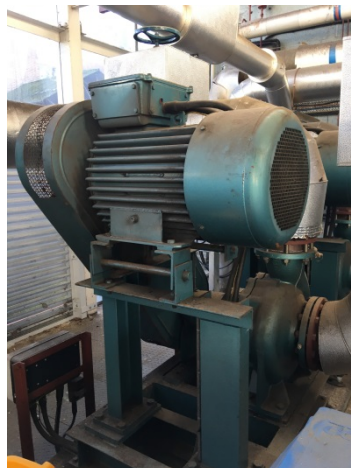
The heat distribution pumps are dated and very energy inefficient. These should also be considered for replacement.

The Trust may wish to consider combining these issues into a single energy centre upgrade or to consider a broader scheme to upgrade the energy infrastructure as part of a carbon reduction initiative.

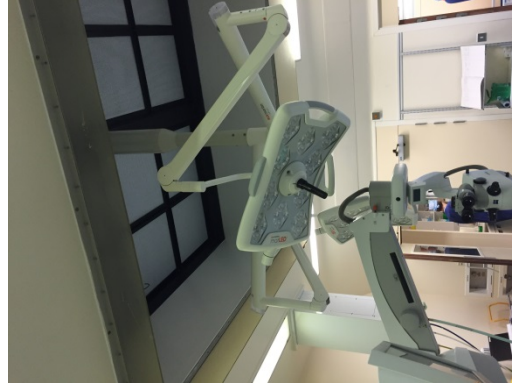
Operating theatres ventilation does not comply with current (nor previous) design guidance. A recirculation system is employed with bespoke ultra clean systems. This is dependent on all supply air being h.e.p.a filtered and routine microbiological testing. This varies significantly from all recognised standards and should not be seen as good practice. Additionally, the systems are well beyond their normal expected life.

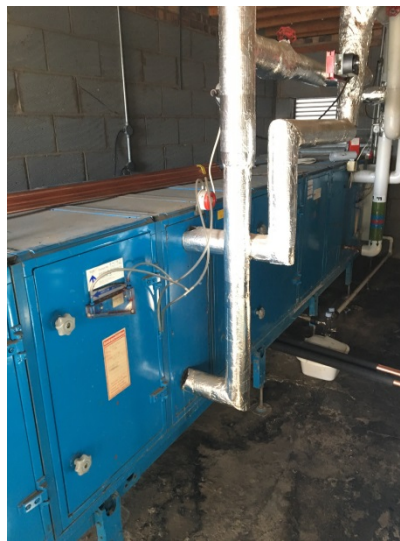
Maternity theatre plant is well beyond its expected life and is in an advanced state of dilapidation. The air distribution system within the theatre will not give adequate flow distribution within the space.

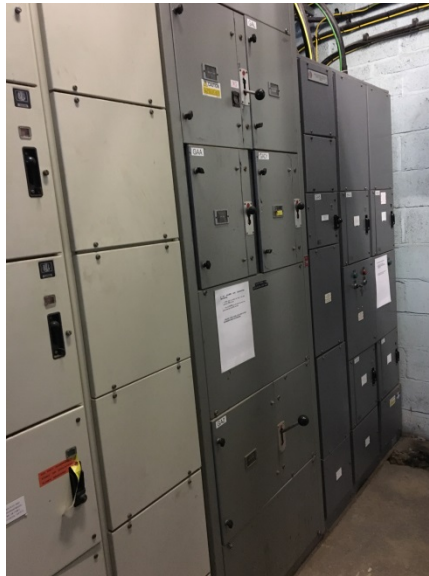
There are a number of concerns with the LV infrastructure, particularly main distribution and section boards. There is an investment need of some £310,000 (exc. fees, vat and temporary supplies etc.) to upgrade aged and failing switchgear. The following summarises the requirements:

Dept/level.	Sub Element	Defect	Remedy
A-Sub LV Switchgear	Electrical Main Distribution	Malfunctioning Switch & Now Exceeded Life Expectancy	Replace
B-Sub LV Switchgear	Electrical Main Distribution	Now Exceeded Life Expectancy	Replace
Main DB & change-over panel	Switchgear	Now Exceeded Life Expectancy	Replace
X-Ray DB (Radiology Corridor)	Switchgear	Now Exceeded Life Expectancy	Replace
Medical Block Main Switchgear	Switchgear	Now Exceeded Life Expectancy	Replace
Pathology Lower - main DB & change-over panel	Switchgear	Now Exceeded Life Expectancy	Replace
Pathology Upper – Section-board	Switchgear	Non Compliant & Now Exceeded Life Expectancy	Replace
Old Theatre Block - Uncontrolled Switchgear	Switchgear	Now Exceeded Life Expectancy & Discrimination?	Replace
Under Block 2 - Electrical Switch Room	Switchgear	Now Exceeded Life Expectancy	Replace
