Drayton Road, Abingdon

Safe Routes Review

Document Ref: KU120500/AbingdonSRS/Rev1

September 2014

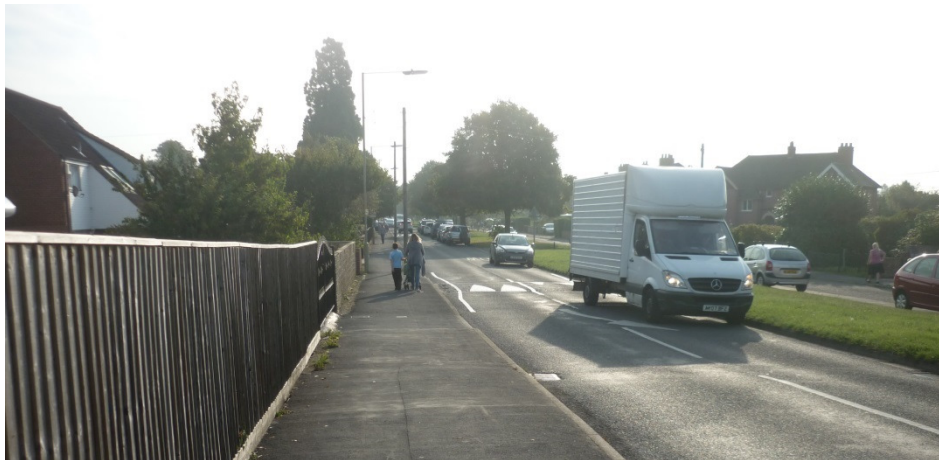
Figure 3-1 Looking east into Caldecott Road from the junction with Drayton Road

From Figure 3-1, it can be seen that traffic flows were light during the site visit (AM peak hour) and there was some parking along the route. Pedestrian and cyclist flows were also quite low. Signs provided at the western end of the road suggest that this forms part of the National Cycle Network (Route 5 signed towards Abingdon town centre) and so it would be expected that this route would be relatively well used by cyclists.

There were no obvious safety issues noted along the route itself, with footways sufficient for the level of pedestrian use observed, and traffic flows low and travelling at relatively low speeds as a result of traffic calming measures provided. This is reflected by the collision statistics, with only one reported injury collision occurring along the route between Drayton Road and its junction with Hermitage Road in the five year period to 31 July 2014. This collision occurred very close to the junction with Drayton Road after a cyclist entered Caldecott Road from the roundabout junction with Drayton Road and fell whilst attempting to access the footway, so it would be reasonable to consider this as having occurred at the junction instead.

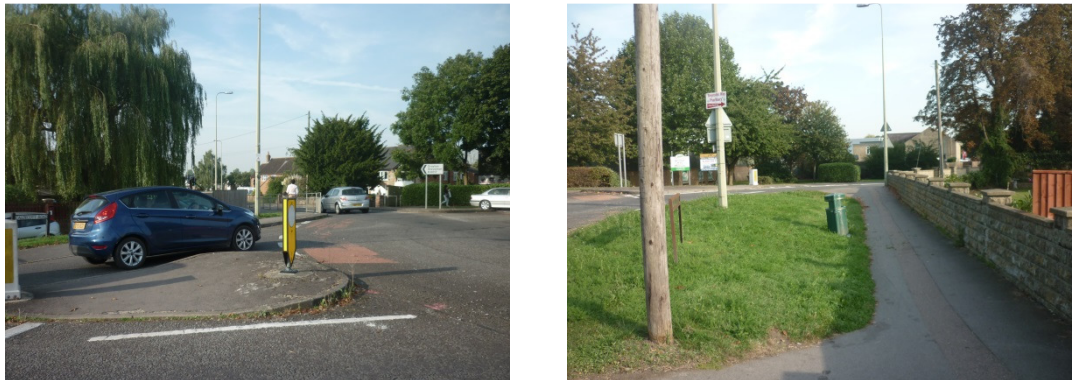
Figure 3-2 Looking west from Caldecott Road towards the junction with Drayton Road

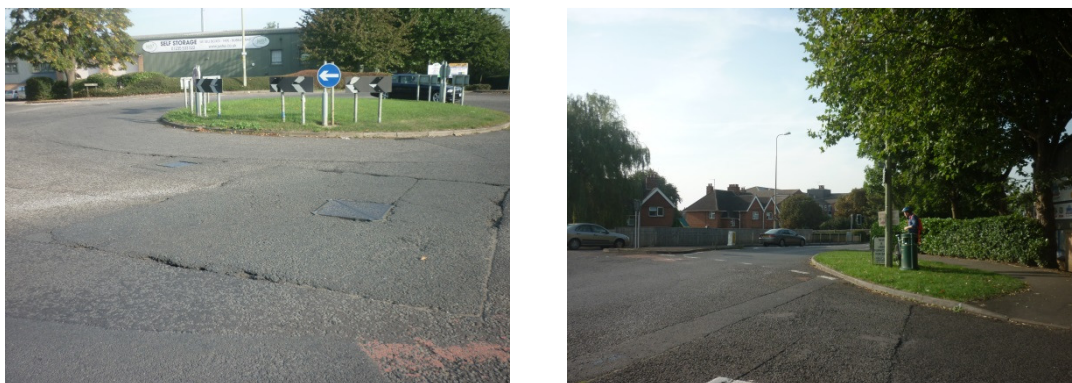
The main traffic movements through the junction are north-south along Drayton Road. During the site visits very few vehicles were observed using the western arm, which provides access into an industrial area (no through route). From site observations, it appears that coloured surfacing was once provided to demarcate a route for circulating cyclists but this is now mostly worn away. The carriageway surface was also in poor condition, road markings were faded and signing was of mixed condition. These issues are illustrated in Figure 3-3.

Figure 3-3 Views of the junction of Caldecott Road with Drayton Road

Including the cyclist collision referred to in the Caldecott Road section of this report there were five reported injury collisions at this junction, of which three involved pedal cyclists and one involved a motorcyclist. This junction clearly presents issues for riders of two wheeled vehicles, but as already noted, it forms part of the signed cycle route to the town centre.

It was concluded that measures to improve safety for pedal cyclists would be of benefit at this junction. Consideration might also be given to reducing the amount of pedestrian guard rail to improve the environment around the junction, although this would be subject to the council's own safety assessment and policy with regard to the provision of pedestrian guard railing.

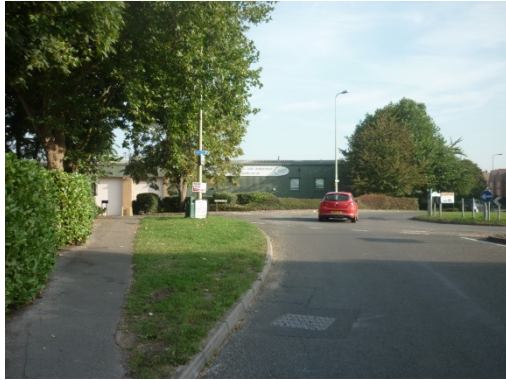
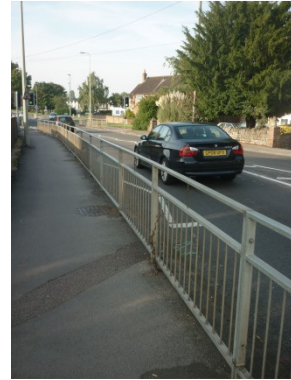
For pedestrians walking north-south past this junction, such as between the proposed development and the schools to the north, it is expected that the preferred route would be likely to be the eastern footway, simply because the walking route is slightly more direct. Pedestrians crossing Suffolk Way to the west of the roundabout are deflected westwards, off the direct desire line, by the alignment of the footway here. The northbound approaches to the junction along both sides of Drayton Road for pedestrians are shown in Figure 3-4.

Figure 3-4 Footways on Drayton Road to the south of the roundabout junction with Caldecott Road

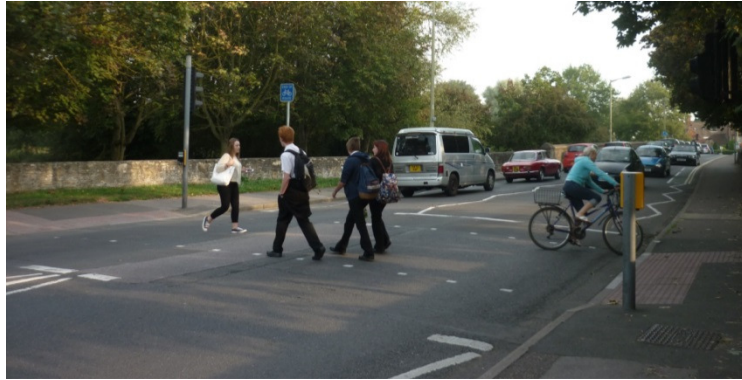
Traffic levels in the morning peak hour were heavy and lengthy northbound queues were observed between the junction with Marcham Road and extending to the south of the crossing. This queue varied in length but cleared quickly outside the peak hour. A safety camera is located on Drayton Road in the vicinity of Ock Bridge Place, facing northbound.

Figure 3-5 Northbound queues on Drayton Road to the south of the junction with Marcham Road

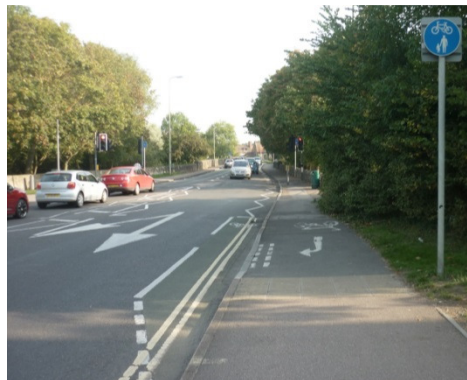
Cycle provision in the vicinity of the crossing appeared confusing in places, with mixed messages provided for cyclists. In the vicinity of the toucan crossing, there is a short stretch of on-road cycle way, 'end of cycle route' signs to Diagram 965 on both footways to the north of the crossing and footways signed for shared use to the south of the crossing on Drayton Road to enable cyclists exiting the Ock River Walk to enter the carriageway to continue their journey southbound. This is shown in Figure 3-6.

Figure 3-6 Inconsistent provision for cyclists on Drayton Road

However, there is no similar facility for cyclists to safely enter the carriageway to continue northbound even though the route for cyclists is again on-carriageway and so the two routes are inconsistent.

It is recommended that cycle markings are refreshed along Drayton Road and the provision of cycle/ pedestrian signing may be of benefit in the vicinity of the Ock River Walk crossing point. There may also be some benefit in rationalising cycle signing where the need to dismount is either very obvious, or may be ignored in any case.

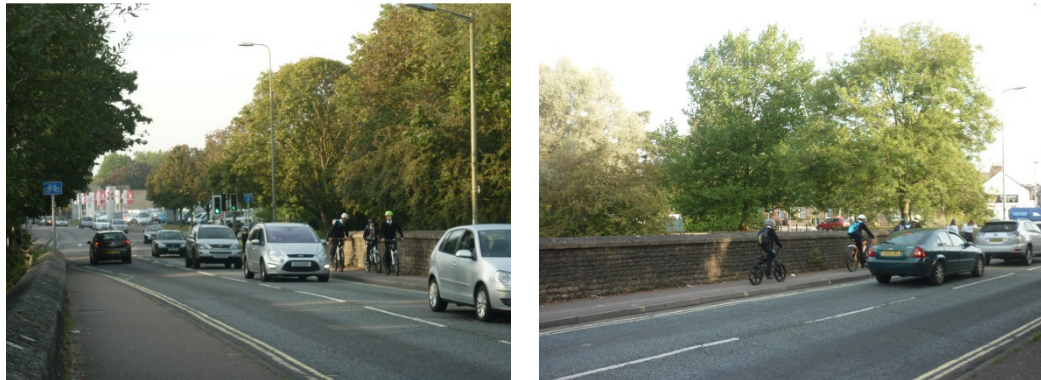
Between this crossing and the junction with Marcham Road to the north, the majority of school pedestrian movements were observed to be along the western footway, with both pedestrians and cyclists heading towards the existing crossing facility provided to the west of the double mini roundabout junction at Drayton Road/Marcham Road, even though this route was not signed for shared use. Footways on both sides of Drayton Road to the north of the crossing were of similar width and quality so the route chosen (east or west side of Drayton Road) would be unlikely to make any difference to the safety of pedestrians when travelling north-south to cross Marcham Road.

Figure 3-7 Northbound Cyclists using the western footway of Marcham Road

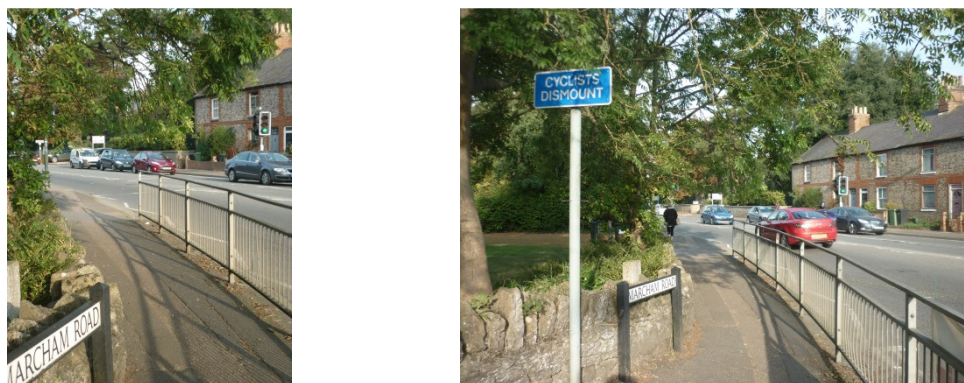
It was noted that footways were narrow on both sides of Marcham Road in the vicinity of the crossing and that a pinch point exists on the south western corner of Drayton Road and Marcham Road as a result of a low wall and pedestrian guard railing. However, cyclists were observed using this footway in preference to the carriageway: possibly because this becomes blocked by traffic queuing from Drayton Road, or because many of the cyclists were quite young and the complex nature of the double mini-roundabout junction may deterred them. Views of this pinch point are shown in Figure 3-8.

Figure 3-8 Pinch point on the southwestern corner of Drayton Road and Marcham Road

It was not obvious why the 'Cyclists Dismount' sign to Diagram 966 was provided on this corner because an 'End of Cycle Route' sign to Diagram 965 was located further to the south on the western footway of Drayton Road, for cyclists travelling northbound towards this location. Footways on both sides of Drayton Road over the bridge to the south of the junction are currently too narrow for conversion to shared use.

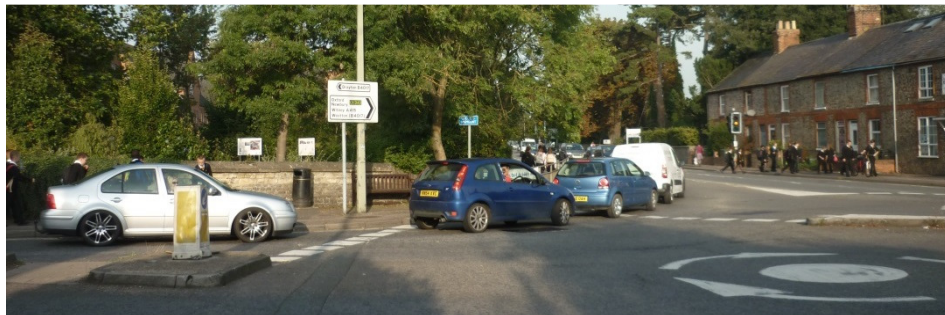
Figure 3-9 Existing crossing used by pedestrians crossing Marcham Road

It was noted on site that there were a few issues associated with the crossing in its current location, as follows:

- Footways were narrow on both sides of Marcham Street at the crossing point, which restricted the available waiting space
- Footway widths on both sides of Marcham Road leading to and from the crossing were adequate for the volume of pedestrian traffic using them for the majority of the time, but were congested for very short periods during school journey times
- The lights were called frequently over short periods during school journey times, which caused a build-up of traffic travelling west from both the south, and east
- The crossing was used by cyclists even though it is not a toucan facility

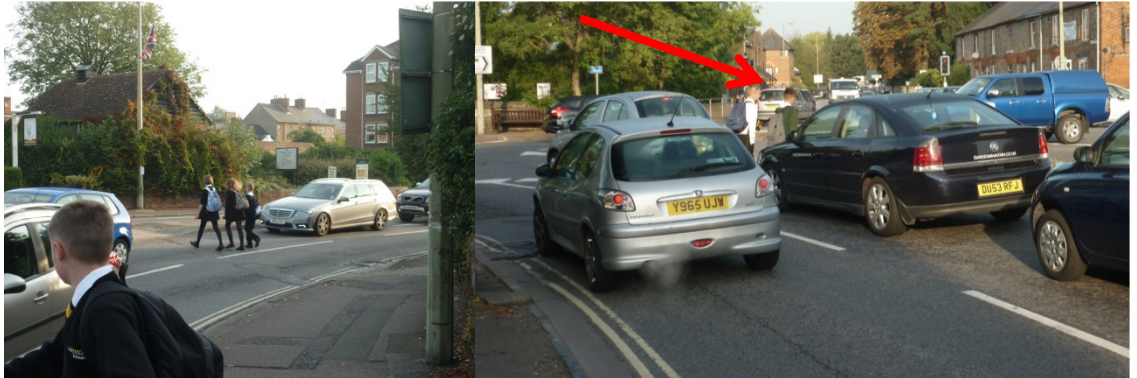
To the east of the junction, a smaller number of students were observed crossing the junction between traffic queues, using the refuge island provided. Although some approached this point along the eastern footway on Drayton Road, the majority had diverted from Drayton Road to the south, onto the Ock River Walk, and approached the crossing from the east, having re-emerged onto Ock Street a short distance to the east. With students crossing between two lanes of traffic at the junction, it was surprising to note that there had been no PICs involving pedestrians at this location during the study period, as these traffic streams travelled at different speeds. High risk crossing movements at this location are shown in Figure 3-10.

Figure 3-10 Crossing movements to the east of the junction

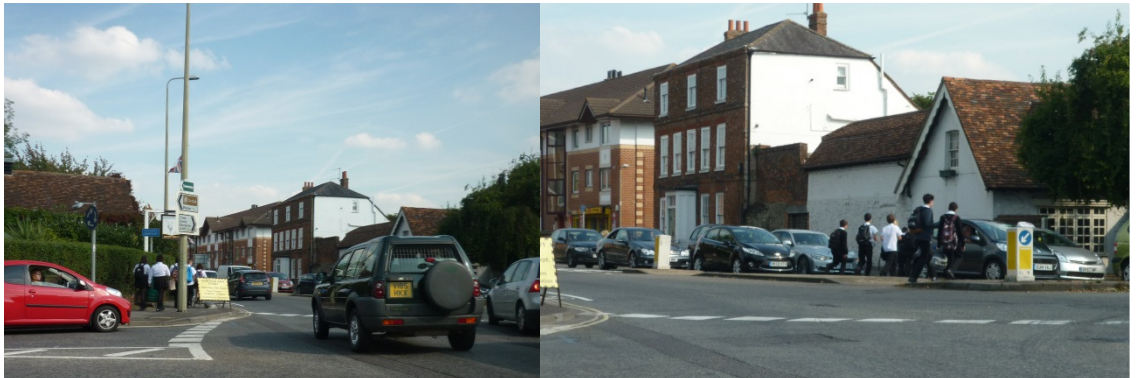
A different walk pattern was observed for the return journey at approximately 3.30pm, however, with a much higher proportion of students choosing to cross Ock Street to the east of the double mini-roundabout junction with Drayton Road than in the morning, with many continuing their journey south via the Ock River Walk route. A small convenience store is located on the south side of Ock Street close to the entrance to the River Walk and which is open during the post-school period. A number of students used this facility on the route home from school and so could be the cause of the different travel patterns observed at this time. This is illustrated in Figure 3-11.

Figure 3-11 Increased crossing movements to the east of the junction in the post-school period

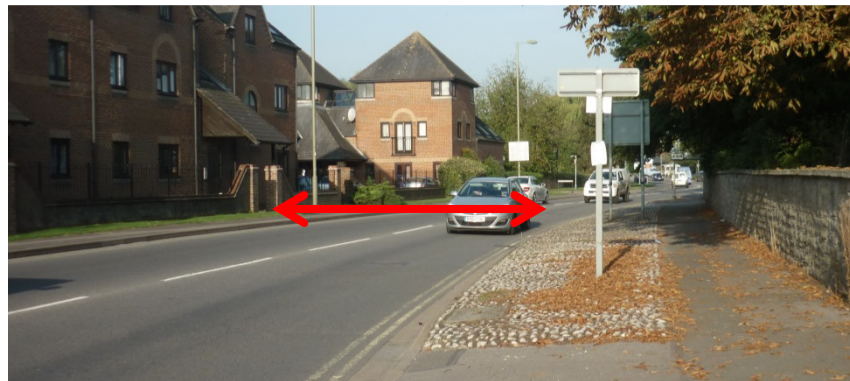
Figure 3-12 Looking west towards the proposed new crossing site

It was noted that the proposed crossing had good visibility in both directions and that the footways were wider than at the current crossing location. However, the textured surfacing on the northern footway would require resurfacing and an existing Advanced Direction sign would need to be relocated so as not to obstruct visibility of and at the crossing. Most critically, however, is that there are concerns that pedestrians travelling between Drayton Road and Spring Road would be much less likely to make use of the facility because of the length of the detour involved.

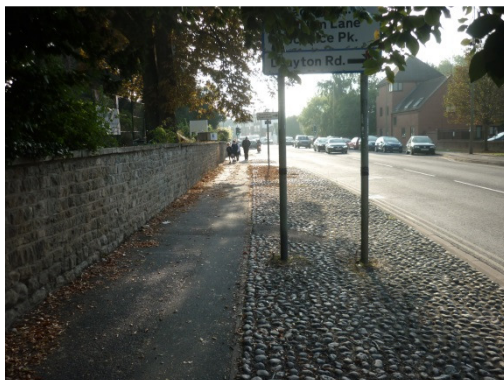
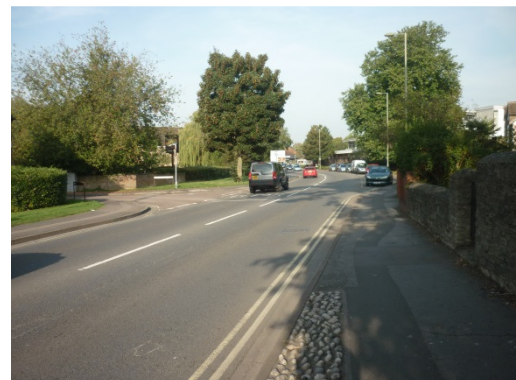
Figure 3-13 Visibility to the east and west from the north side of Marcham Road in the vicinity of the new crossing point

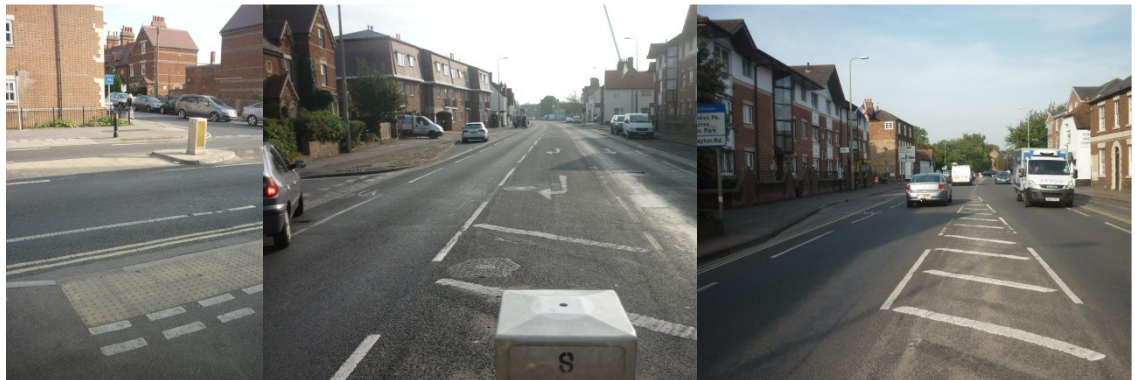
Figure 3-14 Uncontrolled crossing on Ock Street: Looking north, east beyond the study area, and west towards the junction with Drayton Road respectively

Of the nine collisions which took place along Ock Street during the study period, three occurred at this crossing point, of which two involved vulnerable road users: a cyclist was seriously injured on entering the carriageway from the shared use route, and a pedestrian was slightly injured whilst crossing. The third collision at this location involved a single westbound vehicle.

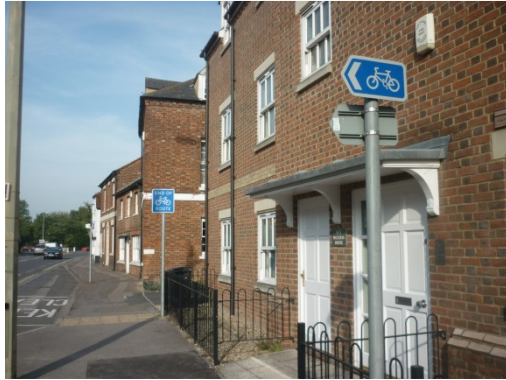
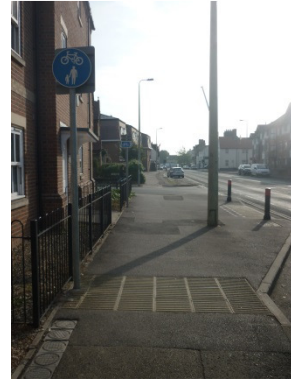
It was noted that cycle signing at the exit from the Ock River Walk route was potentially confusing, with short stretches of shared use facilities provided at either end of the uncontrolled crossing, 'give way' markings provided for cyclists and 'End of Cycle Route' signs provided on the north side of Ock Street to the west of the crossing point. It is assumed that cyclists travelling east from the Ock River Walk route would need to re-join the carriageway. For cyclists approaching the crossing from the east there are both on-road and shared use off-road facilities provided.

Figure 3-15 North side of Ock Street on the approaches to the crossing

The provision of more specific cycle destination signing may be of benefit to cyclists following the signed routes, than the number of generic shared use and 'End of Route' signs to Diagram 965 located on the footway here.

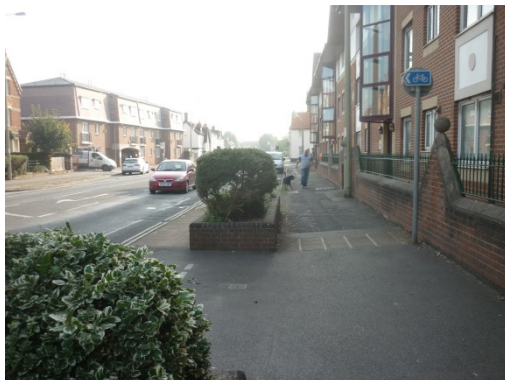
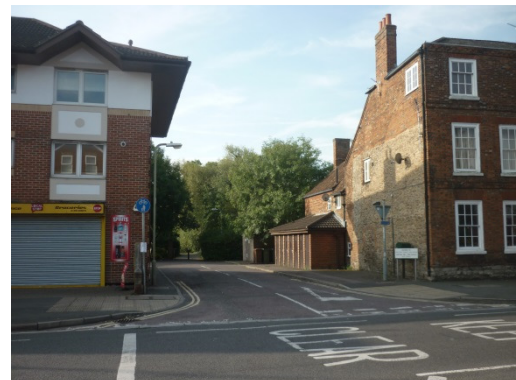
Figure 3-16 South side of Ock Street between the Ock River Walk link and the crossing point

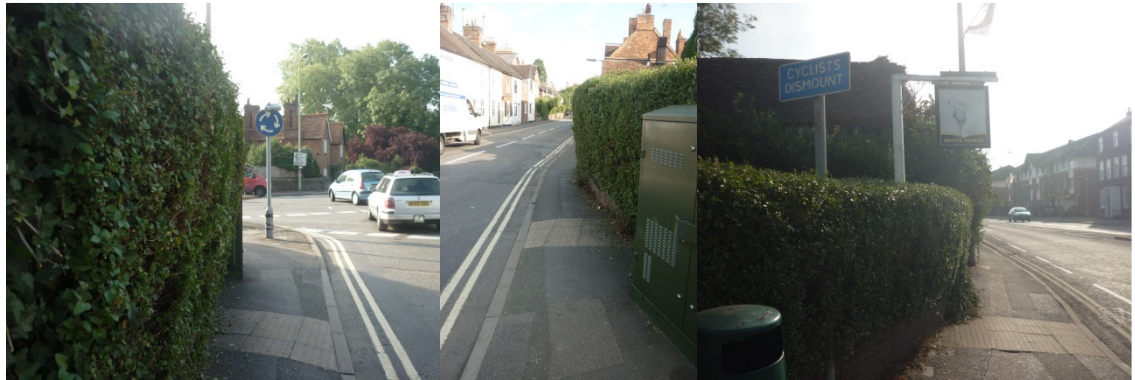
- The northern footway was narrow which reduced the amount of available waiting space for pedestrians
- The signal equipment associated with the crossing may reduce the available width further and potentially create an obstruction which might encourage poor crossing behaviour

- Students would be more likely to use the eastern footway of Spring Road to approach the crossing from the north, which would require them to negotiate a pinch point on the north eastern corner of the junction created by a combination of narrow footways, street furniture and overhanging vegetation, making it more likely that they would walk on the carriageway in the vicinity of the mini roundabout

- A high wall on the north-east corner of the junction restricts visibility round the corner for traffic turning left from Spring Road to Ock Street, which could increase the potential for sharp braking and shunt collisions.

Figure 3-17 narrow footways and a pinch point between Spring Road and the proposed crossing point

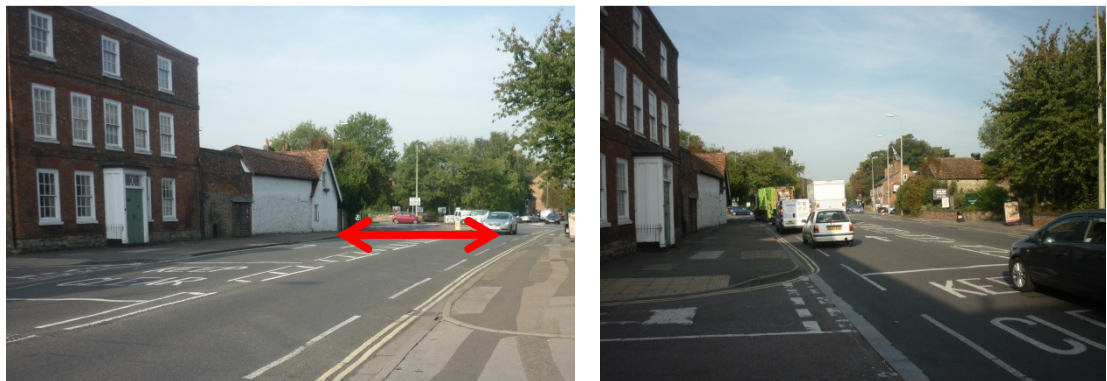
Footways on the south side of the road were wider however and provided an easier link to the Ock River Walk route. Although there was a property entrance on the south side of Ock Street in very close proximity to the proposed crossing point, vehicles emerging will only be able to turn left because of the proximity of the splitter island associated with the junction and so would not conflict with pedestrians using the crossing. The southern footway of Ock Street in the vicinity of the proposed crossing location can be seen in the images included in Figure 3-18.

Figure 3-18 Looking west along Ock Street towards the proposed crossing point

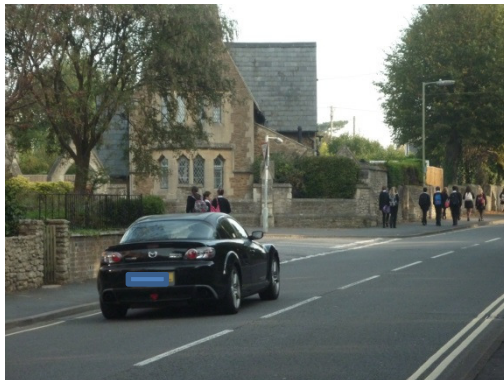
Figure 3-19 Northbound AM journeys mostly on the western footway

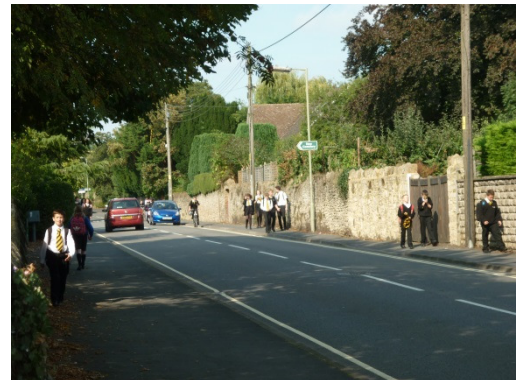
Figure 3-20 Southbound PM journeys along both footways

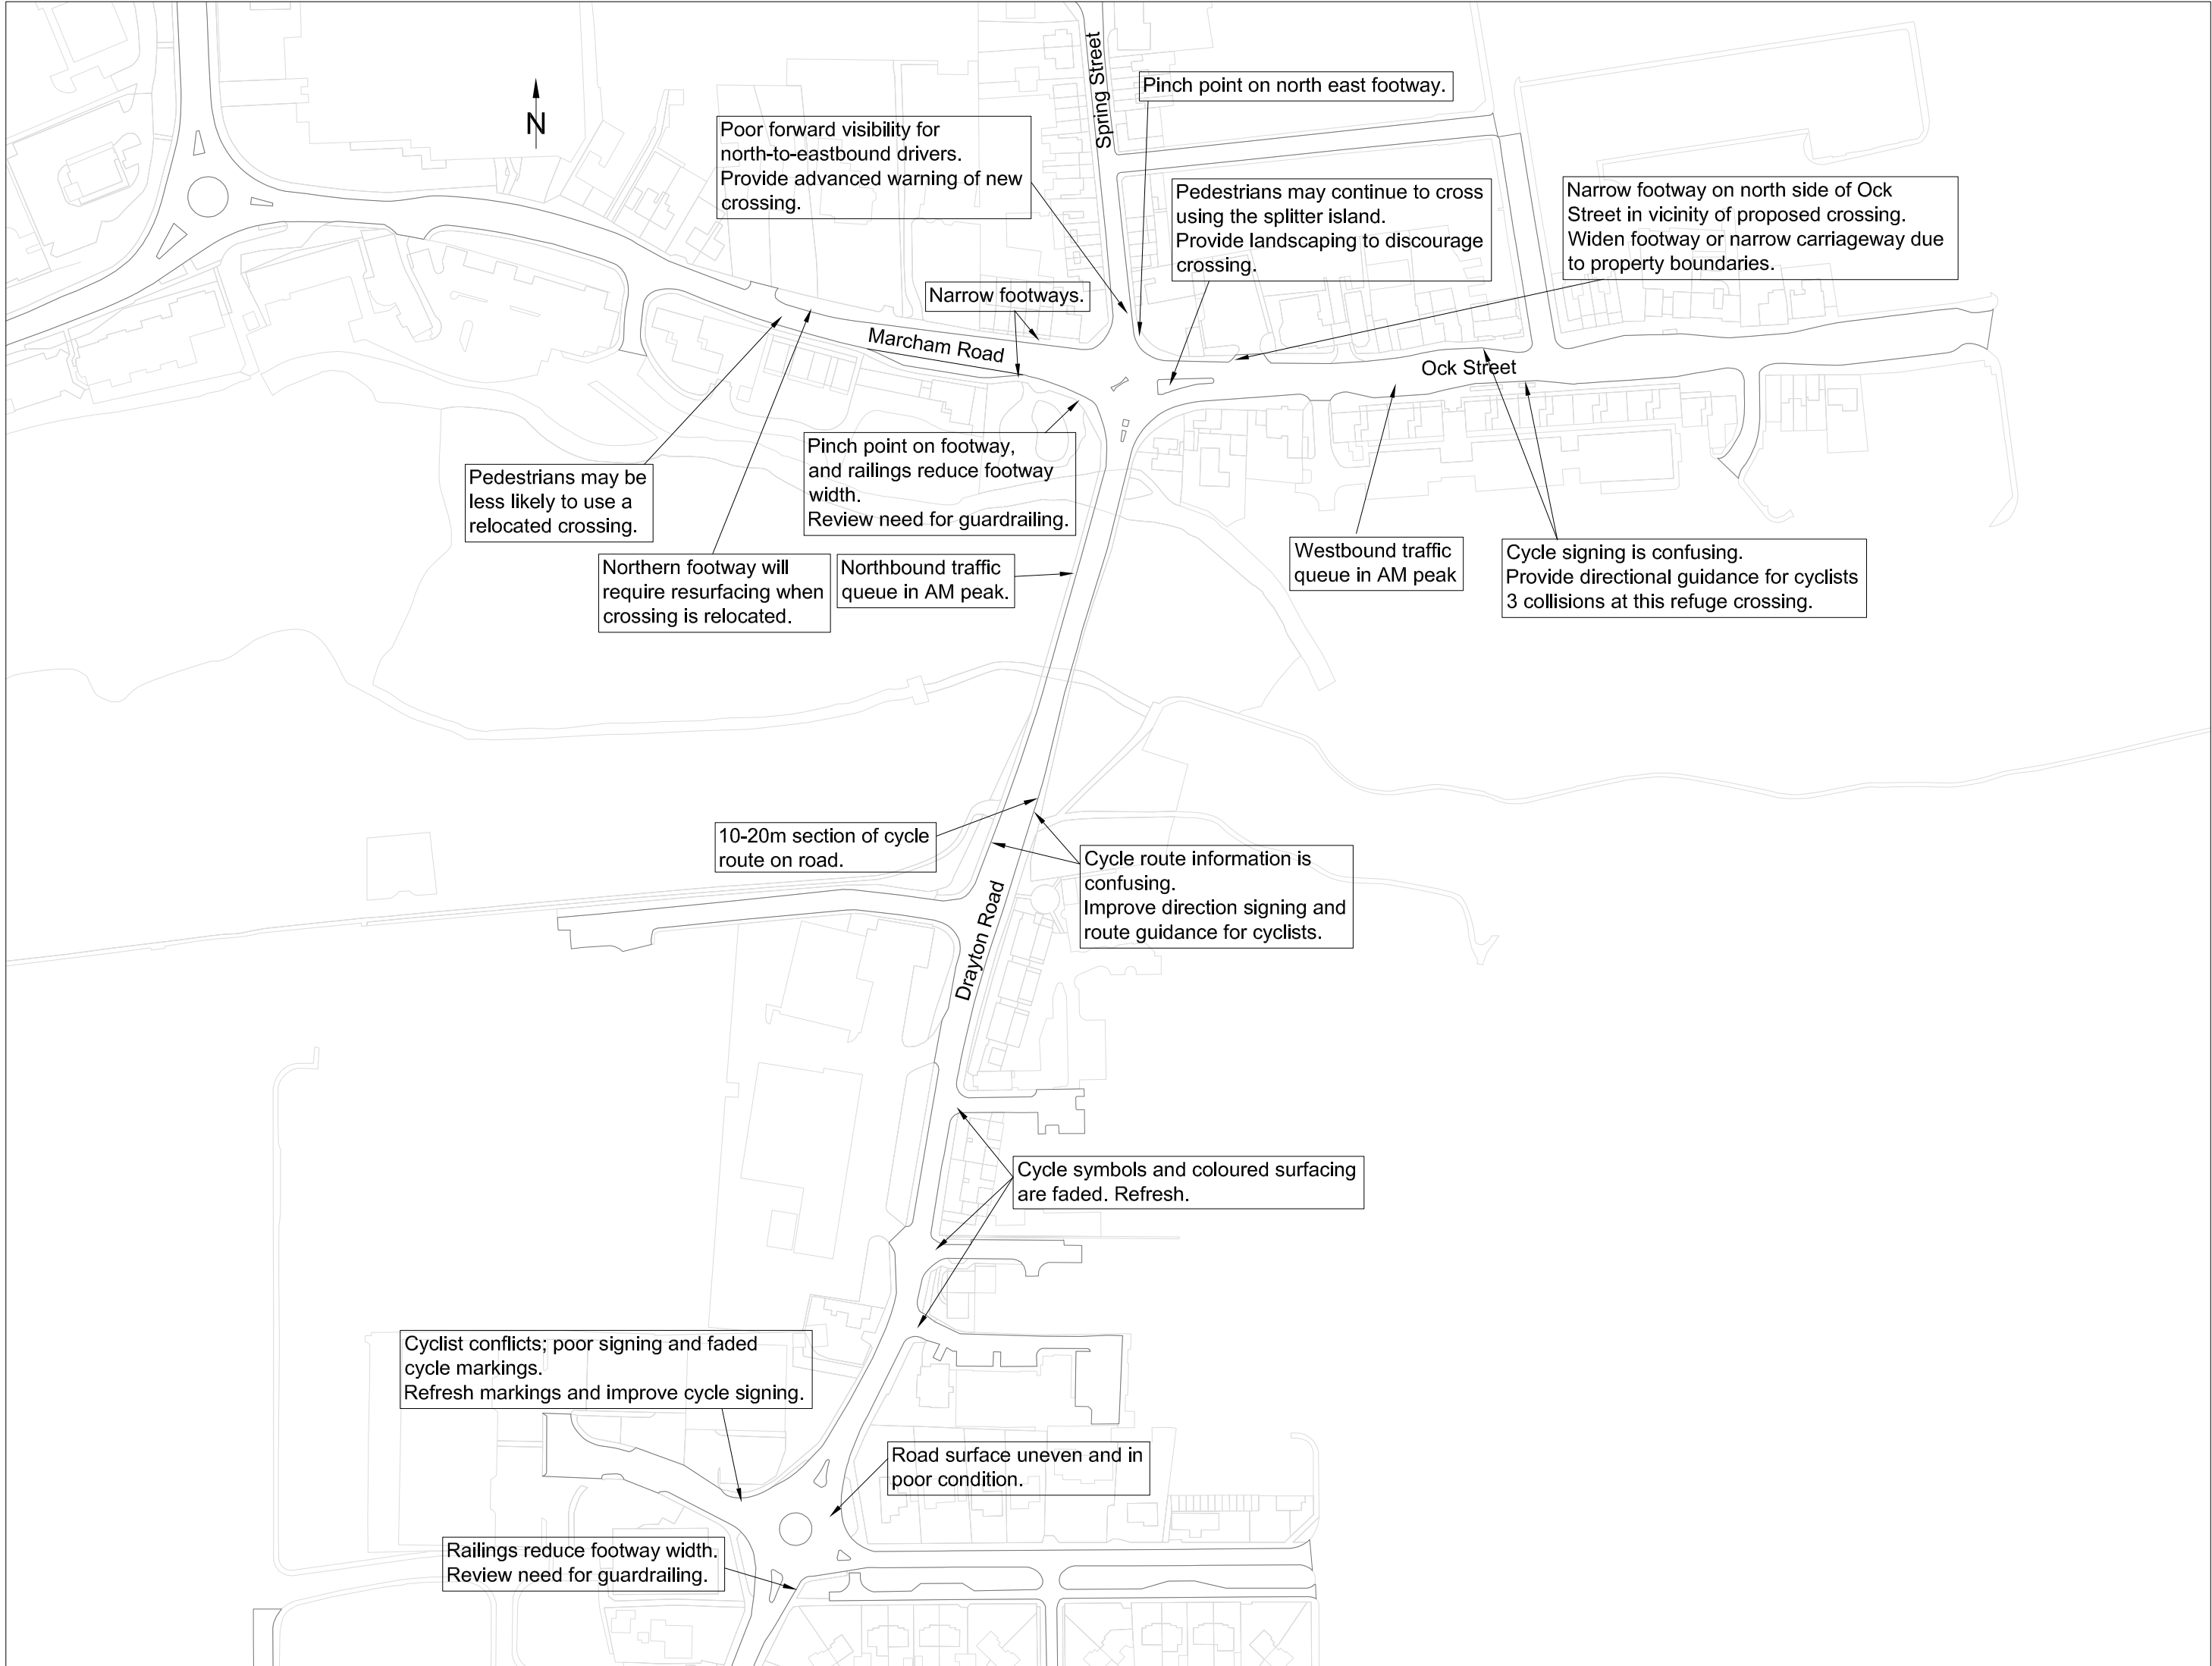
Appendix C Issues and Measures Plan

Poor forward visibility for north-to-eastbound drivers. Provide advanced warning of new crossing.

Pinch point on north east footway.

Road surface uneven and in poor condition.
