Estimate no: JB 22 95

23<sup>rd</sup> February 2022

**Re: Property Inspected -33 High Street, Watlington**

33 HILLY ST, WATLINGTON, OX49 5PZ

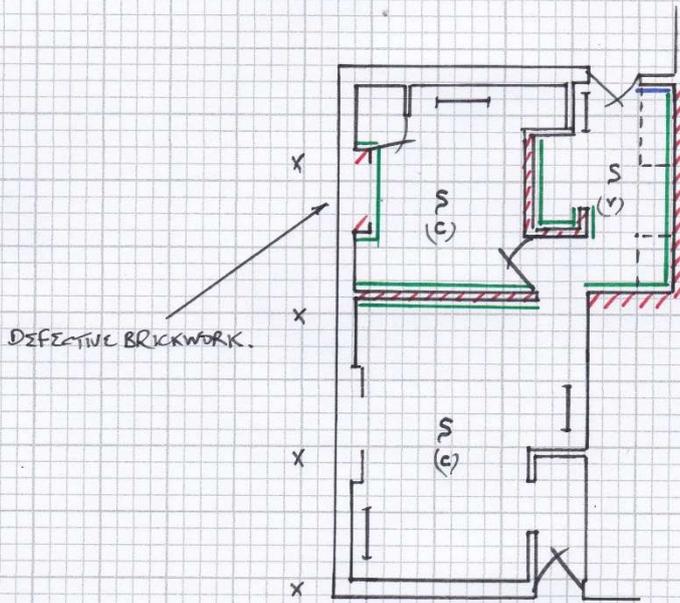
Conductivity meter tests gave patterns normally associated with rising damp (sharp cut-off) in those ground floor walls shown on the attached plan. (HATCHED IN RED.) Rising damp occurs if ground water enters a building by capillary action. Water movement by capillary action is usually controlled by a damp proof course (DPC).

Evidence of "bridging" of the DPC level, by high external ground levels was noted, as indicated on the attached plan. Bridging occurs when the ground level outside of solid wall is higher than the installed damp proof course or when external renders or internal plastering extend down beyond the damp proof course level.

At the time of inspection evidence of penetrating damp was found, as indicated on the attached plan, caused by spalled brickwork and single skin wall to the right of the kitchen door.

The plaster on the walls marked on the plan is decayed. This condition is likely to be the product of residual salts, which may be hygroscopic. For long term durable restoration, all decayed plaster should be removed and replaced with a salt and water resistant plaster system, as per our specification. If plaster is not replaced by us following the installation of a chemical damp proof course any future claim under the guarantee will be restricted and will not include any repairs to plasterwork.

DEFECTIVE BRICKWORK.

We recommend the installation of a chemical DPC to the walls hatched in red, as per plan attached. All abutting walls will be isolated by vertical injection to a minimum height of 1.5 metres, or to the full height of external abutting structures, if higher.

The plaster will be removed to a height of 1.5 metres and replaced to our specification as indicated in the areas marked on the attached plan with a single green line. Two coats of sand and cement (render) in the ratio 3:1 will be used, incorporating a salt inhibitor and waterproof additive. A finishing skim coat of multi-finish plaster is applied over the render background (to full height)

We recommend the installation of a John Newton damp proofing membrane system to help control the varying types of dampness that are present. The membrane has the benefit of controlling rising and penetrating damp and when finished with a plasterboard dry lining system it will also help to reduce the effects of cold wall condensation. The membrane and dry lining system will be installed full height to the walls unless otherwise specified. A finishing skim coat of multi-finish plaster is applied over the plasterboard. If there are any electrical sockets/switches or radiators on the walls these would need to be decommissioned and removed from the areas prior to works commencing.

WALLPAPER.  
SKIM WALLS FULL HEIGHT.
