Claydon Canal Bridge

CS 470 Management Of Sub-Standard Structures Report

December 2025

Doc. Ref. 870060-MIL-SBR-244-RA-CB-0042

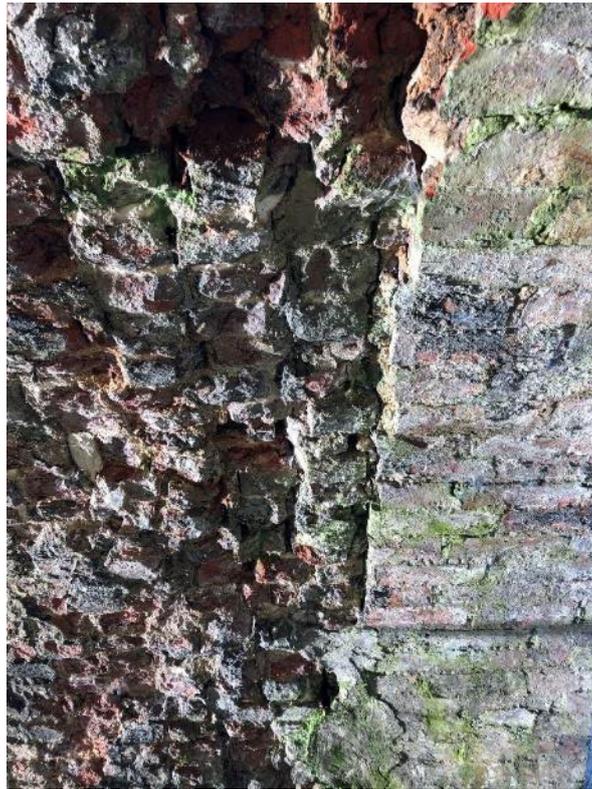
There is evidence of spandrel wall cracking at the interface between the intact brickwork at the voussoir and the main arch barrel. The exact width, depth, and extents of this cracking are difficult to determine due to spalled arch barrel and historic mortar repairs over the crack.

Figure 2-1: Photo of arch barrel close to north elevation along interface between voussoir and main arch barrel section [2024].

Firstly considering the arch barrel, historic mortar repairs have not been successful, and where the mortar is now spalling it is taking the surface of the brickwork behind with it too. Spalling is to both bricks and mortar joints, and is extensive throughout the intrados of the arch barrel. It is not obvious where mortar repairs can be completed and to what benefit. Lime-based mortar could be injected into the spandrel wall cracking to help slow the rate of deterioration at that interface and reduce the risk of bricks adjacent to the crack dropping out.

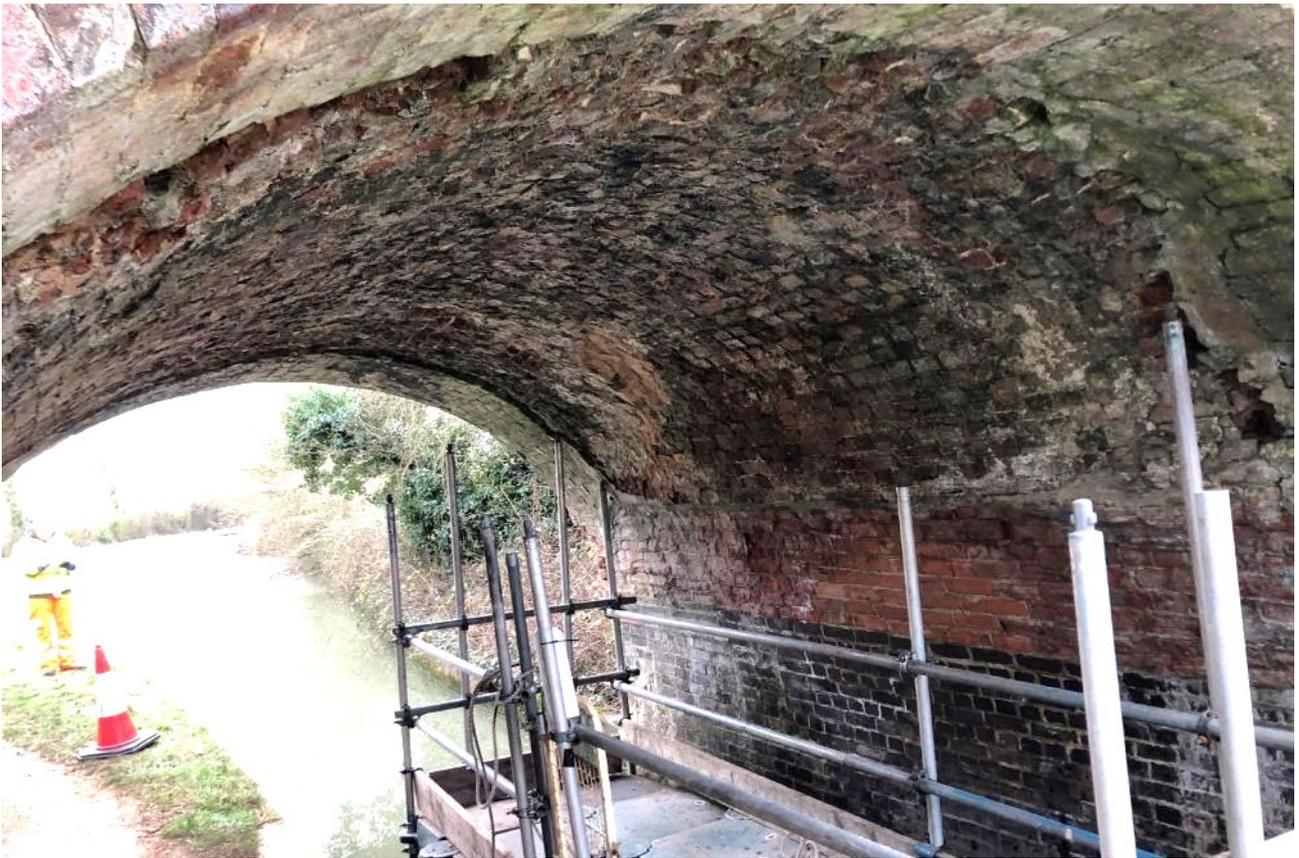
There is evidence of historic brickwork repairs and render/mortar repairs as seen in Figure 2-2. The brickwork repairs around the springings generally appear to have been successful as the brickwork is clearly in significantly better condition than the rest of the arch barrel which has extensive spalling.

Historic render/mortar repairs have been unsuccessful and are spalling off. Where the render is spalling, it appears to be taking brickwork and mortar behind with it. The render repairs may also be masking defects and deterioration of the brickwork underneath. The brickwork around the outside of render repair areas also appear to be deteriorating at a quicker rate than the rest of the brickwork which indicates that the render/mortar is changing how moisture moves through the structure, impacting the rate of deterioration.

Figure 2-2: Intrados of arch barrel, historic repairs in stretcher bond visible above the blue brick abutments on the right of the photo [2024].

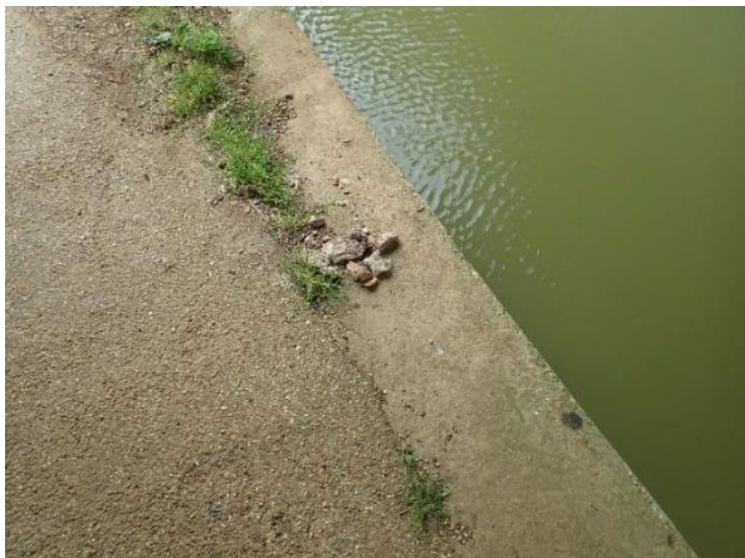
Previous inspections have found evidence of dropped spalled material on the towpath as shown in Figure 2-3. It is unlikely that a towpath user will be struck by falling debris, but the fragments on the towpath may create a trip hazard which poses an increased danger due to the canal immediately adjacent.

Figure 2-3: Evidence of dropped material from the intrados [2019].

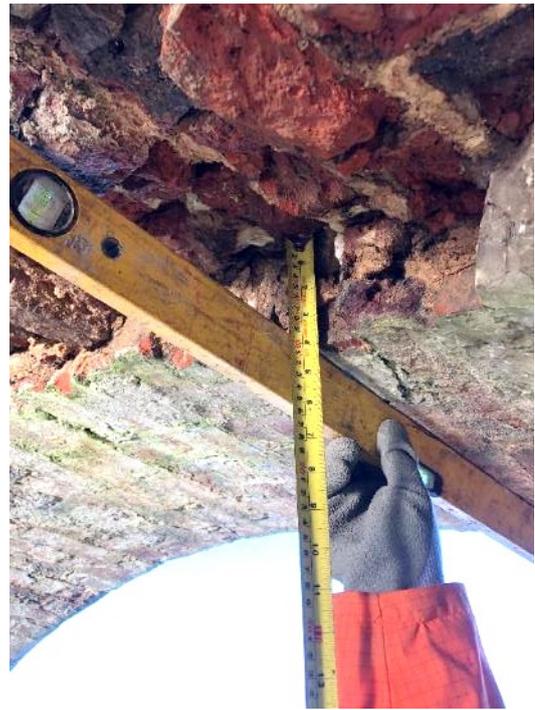
The main arch barrel has approximately 60-80% spalling across its total area at the intrados. The depth of spalling varies from minor surface and pointing loss to a maximum measured spall depth of 95mm at the north end of the arch barrel. (Areas of spalling may penetrate deeper than the values measured with a tape). This is likely largely due to freeze-thaw action and movement of moisture through the brickwork. The rate of deterioration may be exacerbated by frequent usage of the structure by over-weight vehicles (such as agricultural vehicles) which may be causing the structure to flex under loading.

Figure 2-5: 95mm spalling depth measured at north end of arch barrel near crown [2024].

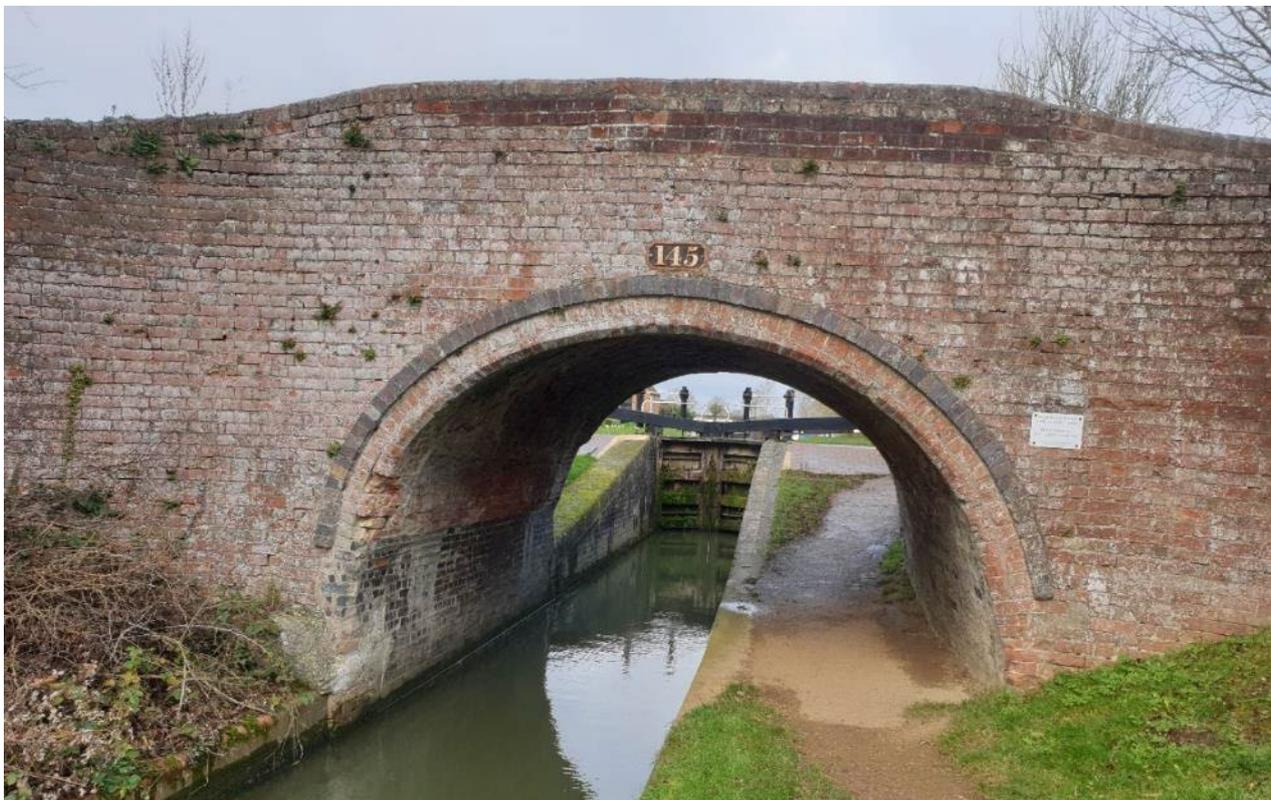
Figure 2-6: South elevation of Claydon Canal Bridge [2021].

There are missing and damaged bricks to the voussoir close to the south-west springing as can be seen on left of Figure 2-6. There is severe brickwork section loss at the north-west end of the arch where 10no. voussoir bricks above the springing have 50-80% section depth loss as shown in Figure 2-8. These defects are likely the result of canal boat collisions/scraping with the structure. Defects to the voussoir and spandrel wall sections of the arch are unlikely to affect the bridge's capacity due to the spandrel wall cracking separating the voussoir from the main arch barrel.

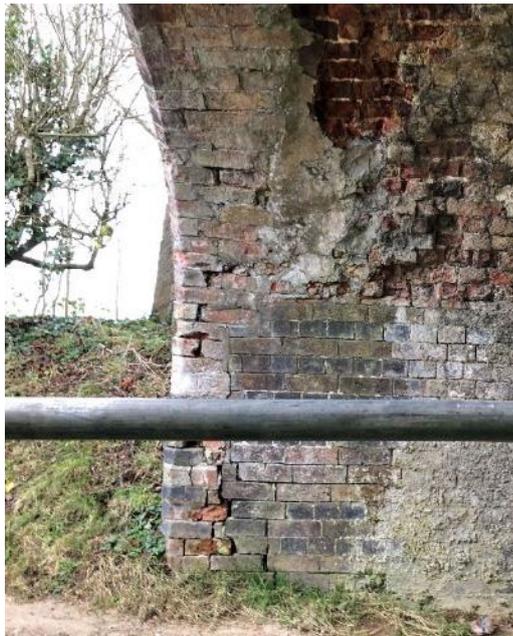
The abutments are generally in good condition. There is extensive vertical cracking and general deterioration of the masonry at the north end of the east abutment as shown in Figure 2-9.

Figure 2-9: North-east abutment [2024].

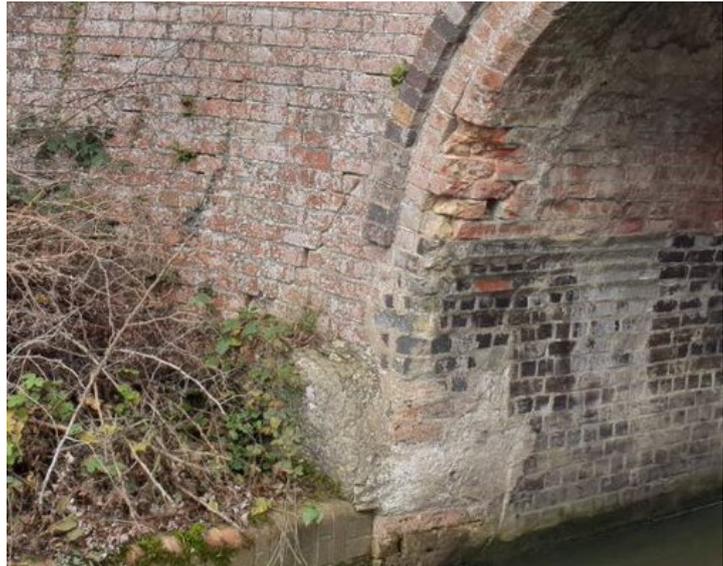
The wing walls, spandrel walls, and parapet are generally in moderate condition with extensive efflorescence to the surface. There is stepped cracking at the base of the south-west wing wall as shown in Figure 2-10. This may be indicative of settlement of the west abutment. There are other areas of general mortar loss, brick displacements, and cracking around the structure.

Figure 2-10: South-west springing and wingwall showing stepped cracking in brickwork [2022]

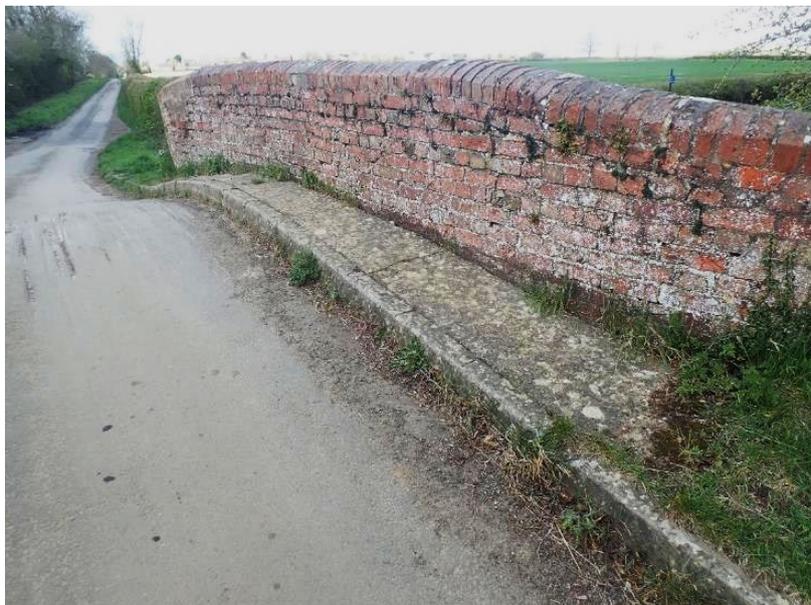
The carriageway over the structure is humped with scrape marks in the road from undercarriage scrapings, visible on the left of Figure 2-11. Undercarriage scrapings might be indicative of larger, and therefore heavier vehicles which may be overweight using the structure.

Figure 2-11: Parapet over the structure (prior to damage in 2024), concrete verge, and carriageway with undercarriage scraping marks [2021]

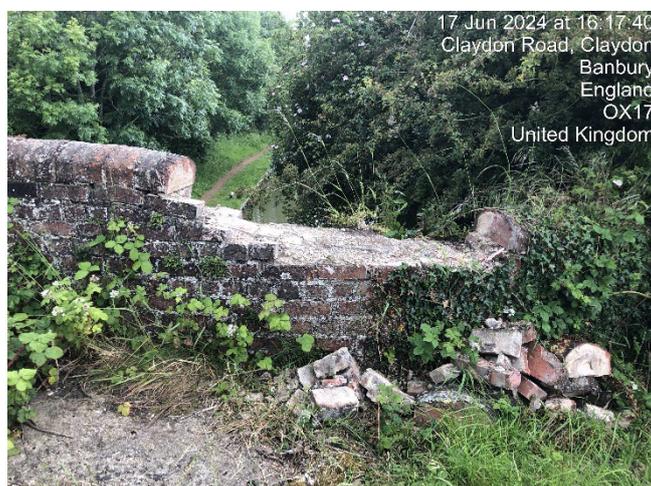
The parapet was struck in 2024 by purportedly local district verge grass cutting works. This caused an area of 2.1m x 0.45m of parapet brickwork to fall onto the west bank and into the canal. A section of parapet is therefore missing as shown in Figure 2-12. Although there is no official footway over the structure, it is still used by pedestrians meaning there is a 2.4m length section of parapet which is significantly sub-standard.

Figure 2-12: Section of damaged parapet [2024].

The section of missing parapet poses an increased risk of falls from the bridge deck. Although there is no official footway over the structure, the bridge is still used by pedestrians. The parapet is of sub-standard height anyway so this existing risk is further increased.

Loose brickwork has already been removed from the damaged area to reduce the risk of brickwork falling onto canal users. There is an increased risk that adjacent brickwork has been loosened as a result of the strike causing further bricks to drop from the parapet.
