Green Road, Oxfordshire

Date of survey	8 June 2026
Surveyor's name	Matt Judson
Surveyor's position	GLASS Representative for Oxfordshire

Assessment by the Green Lane Association

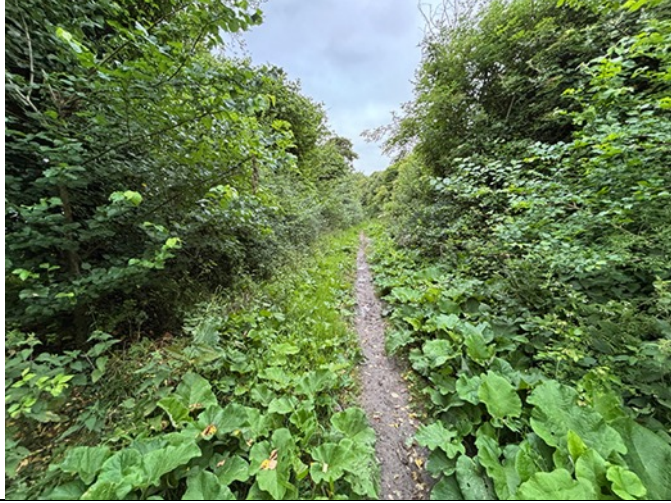
12 - Ordnance Survey grid reference SU 3799 8734

At the beginning of the eastern end of the byway (12) the width is in excess of 10m between boundary fences, several concrete blocks have been placed at this point to stop passage along the Byway for carriages and motor vehicles.

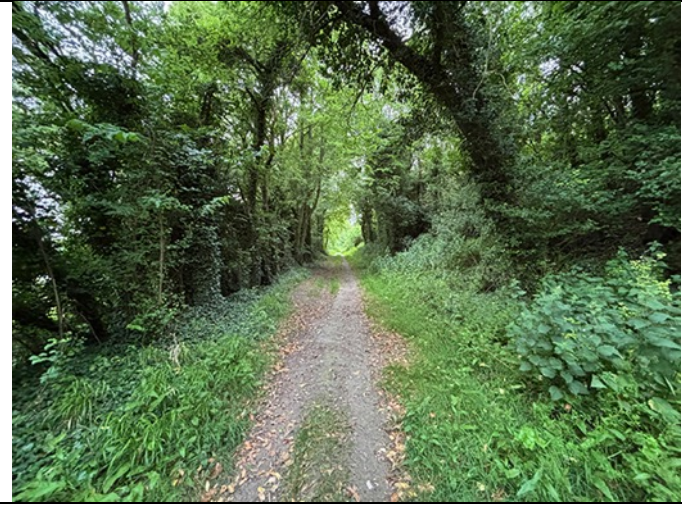
Ordnance Survey grid reference SU 3758 8706

This image shows a good example of the general condition of the eastern section of Green Road.
