Letcombe Regis/West Challow BOAT, Oxfordshire

Date of survey	8 June 2026
Surveyor's name	Matt Judson
Surveyor's position	GLASS Representative for Oxfordshire

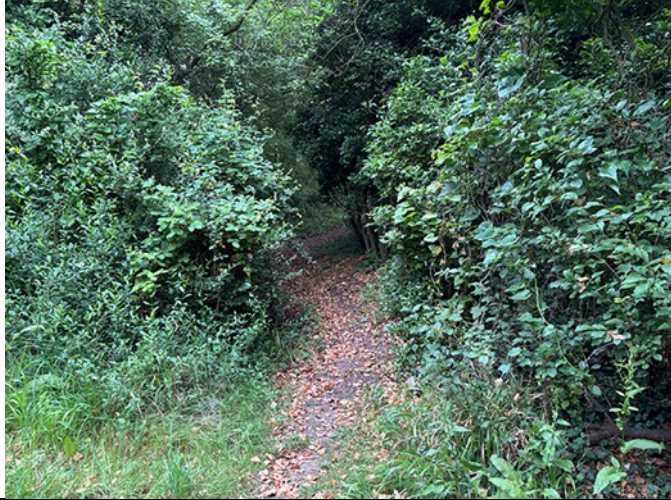
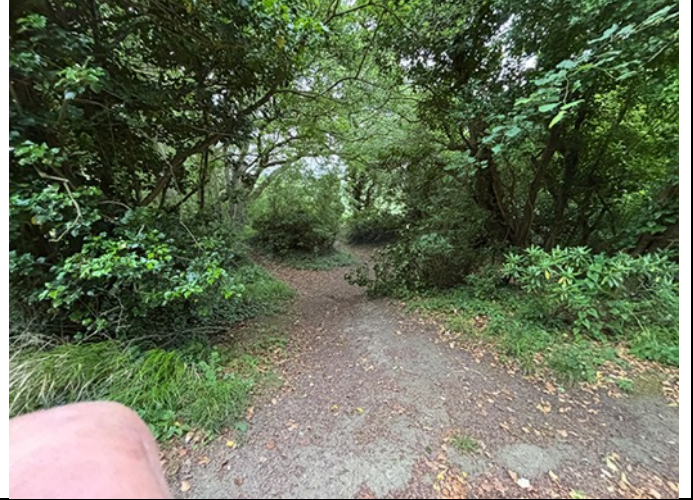
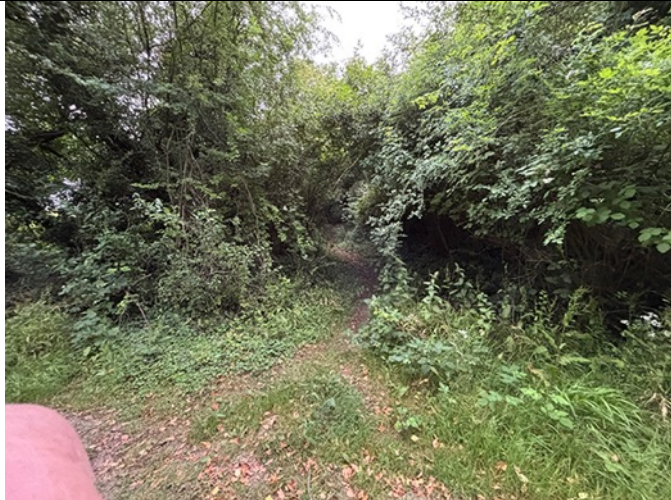
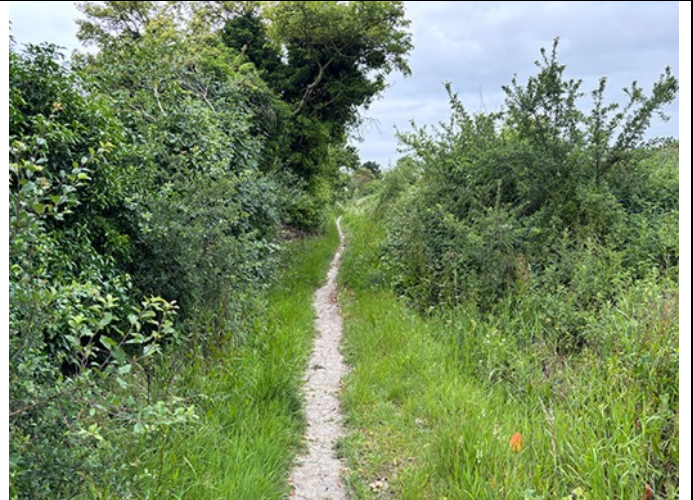
9 - OS Grid reference SU 3750 8700

At the junction with Green Road (9), the byway is very open, however overgrowth of trees is stopping sunlight getting to the surface and drying it out. At the time of the survey, the surface was dry and able to take all types of traffic.

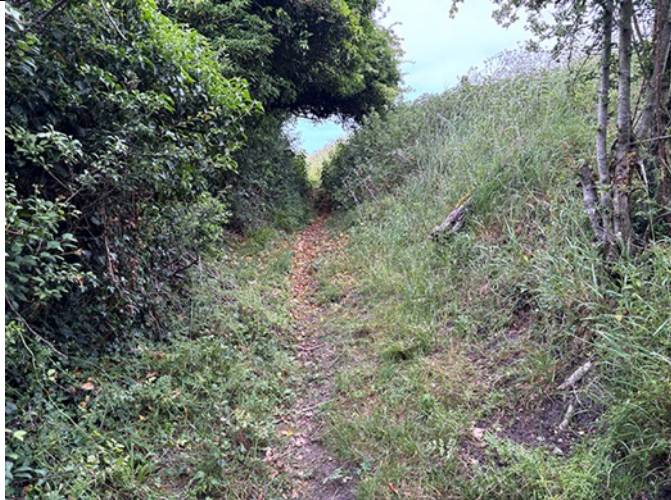
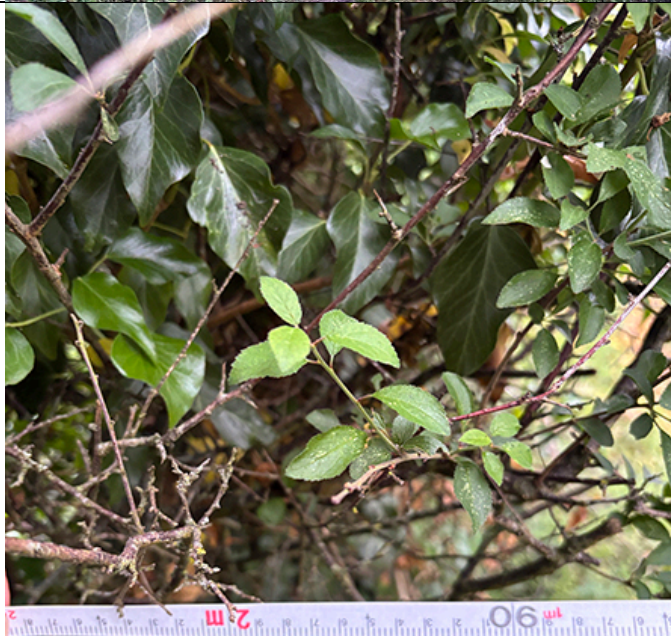
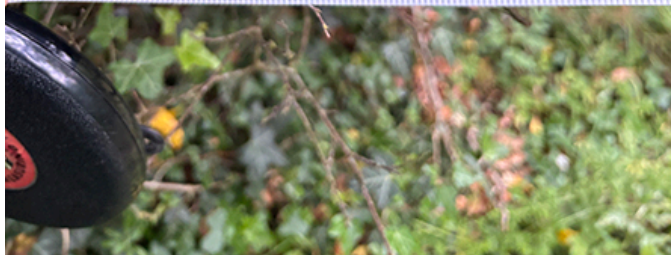
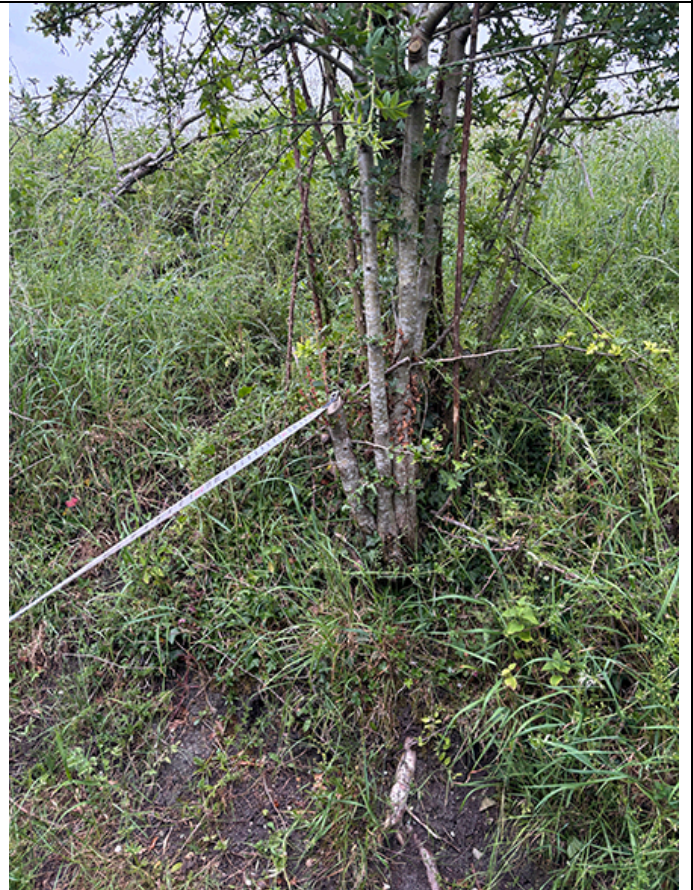
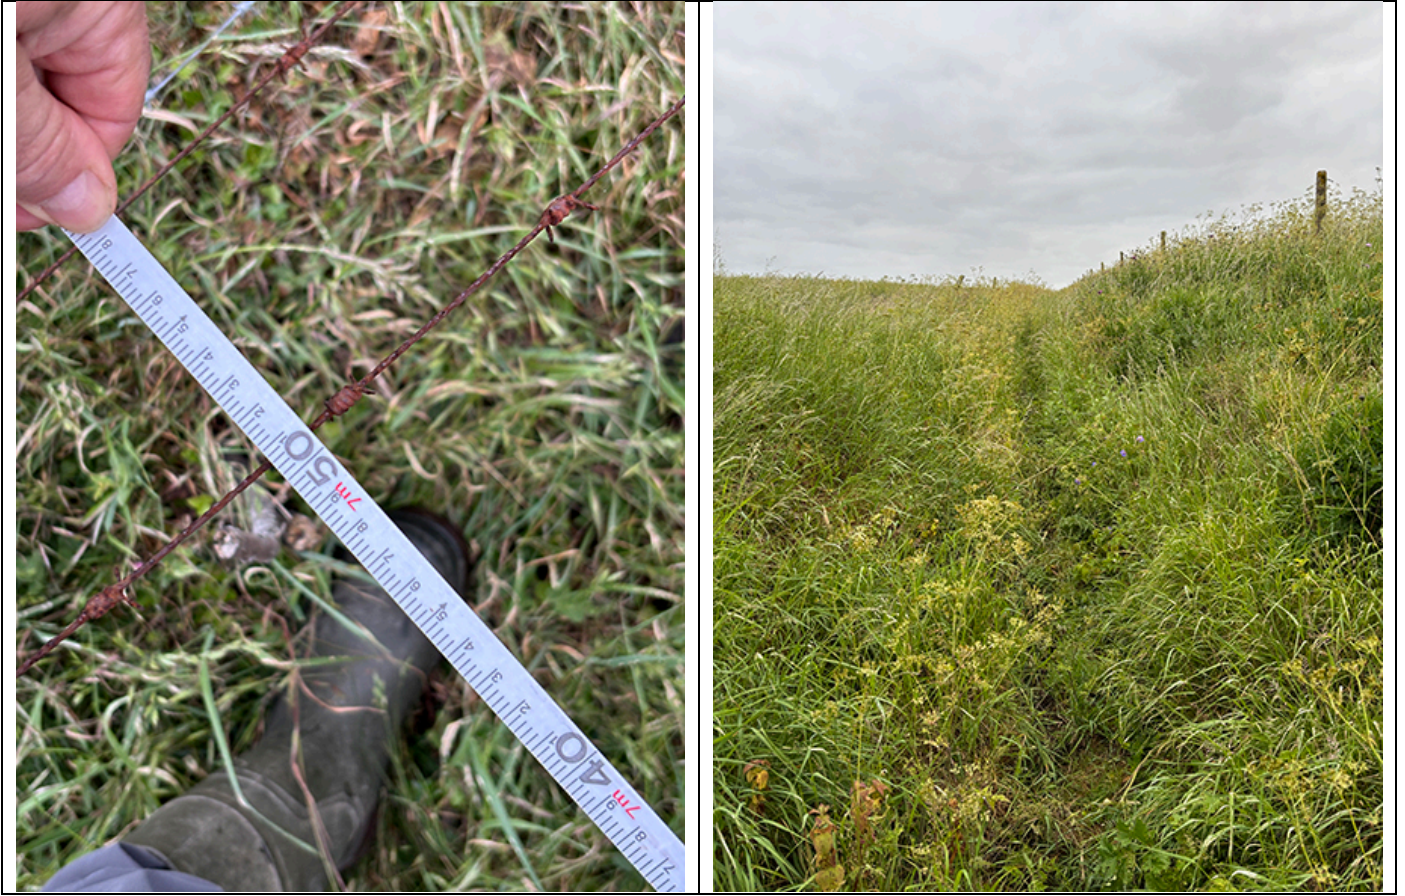
10 - OS Grid reference SU 3745 8705

Going northeast from the crossroads (9-11), the byway becomes very enclosed by vegetation but is in excess of 10m wide between boundaries. To the right of the byway is being used as a 'play' area with evidence of shelters having been constructed in the past. The byway narrows between vegetation to its narrowest at point 10. At this point there is a visible 2m width between bushes that have established in the surface of the byway however between boundary fences, the route measures 7.5m.
