**Cabinet
Tuesday, 19 July 2022**

**17. Didcot Garden Town HIF1 - Compulsory Purchase and Side Road
Orders (Pages 1 - 718)**

Transport Assessment Part 3

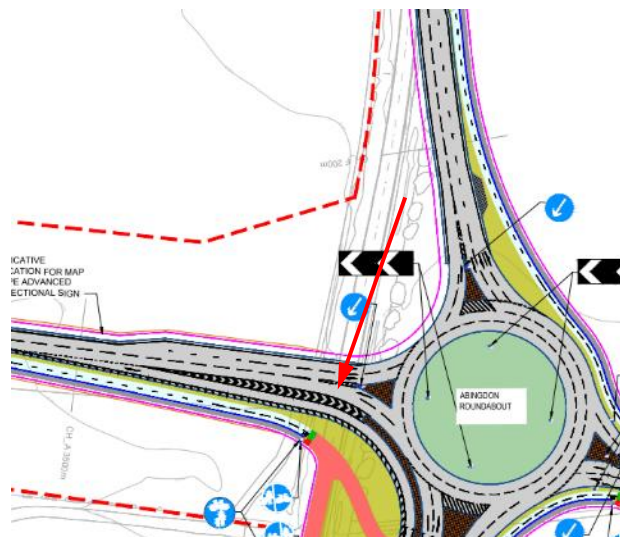
Drawing: RIV_PD-ACM-HGA-SW_ZZ_ZZ_ZZ
DR-CH-0008 Rev P03

Summary A two-lane roundabout exit will increase the risk of conflict between southbound vehicles and a vehicle emerging from the segregated left turn lane

A segregated left turn lane (SLTL) will be provided between A415 Abingdon Road westbound and the link road. The roundabout exit upstream of the SLTL merge provides for a two-lane roundabout exit.

It is recommended that the centreline road markings downstream of the roundabout exit are removed, and the roundabout exit reduced to a single lane with the use of offside tapered hatching road markings.

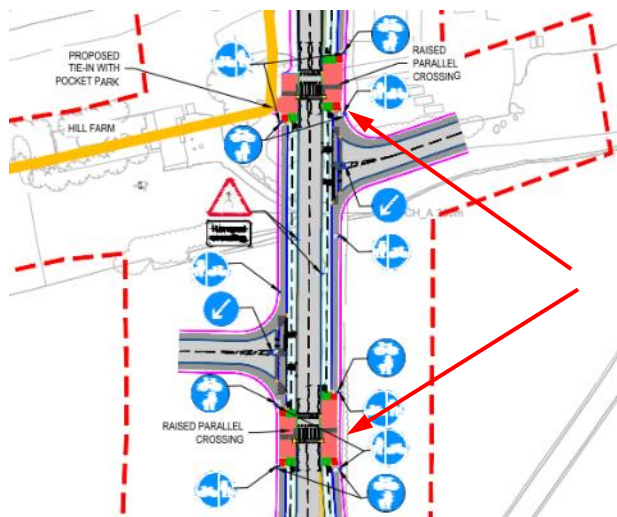
Summary The close proximity of the controlled crossings to one another could lead to vehicles failing to stop at the subsequent crossing

Two Parallel crossings will be provided across the link road in close proximity to one another just to the north of the Collett Roundabout. The northern crossing has been provided to tie-in with Pocket Park and the proposed re-routing of a bridleway – a Pegasus crossing is proposed across the link road further north.

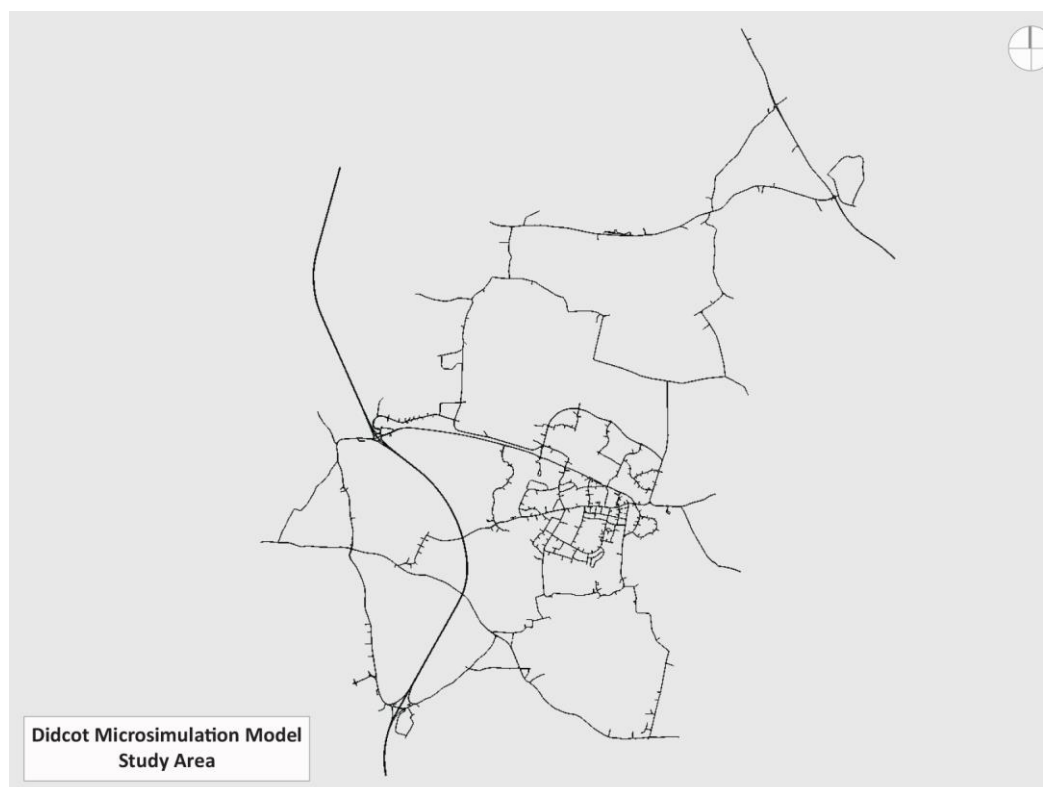
Figure A.1 : Study Area

The geographical coverage of the model is shown in Figure A.1.

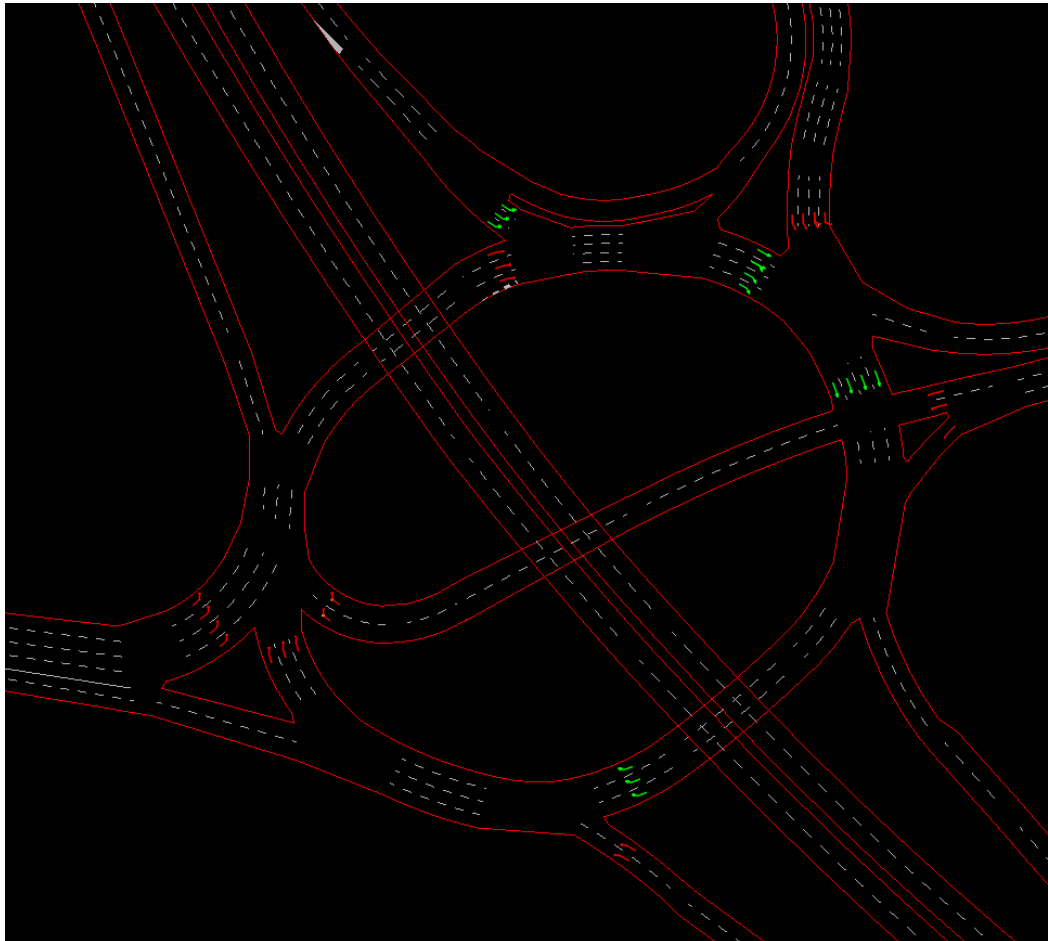
Figure A.2 : Milton Interchange, as coded

As an example of the network coding, Figure A.2 below shows the Milton Interchange, as coded in the model.

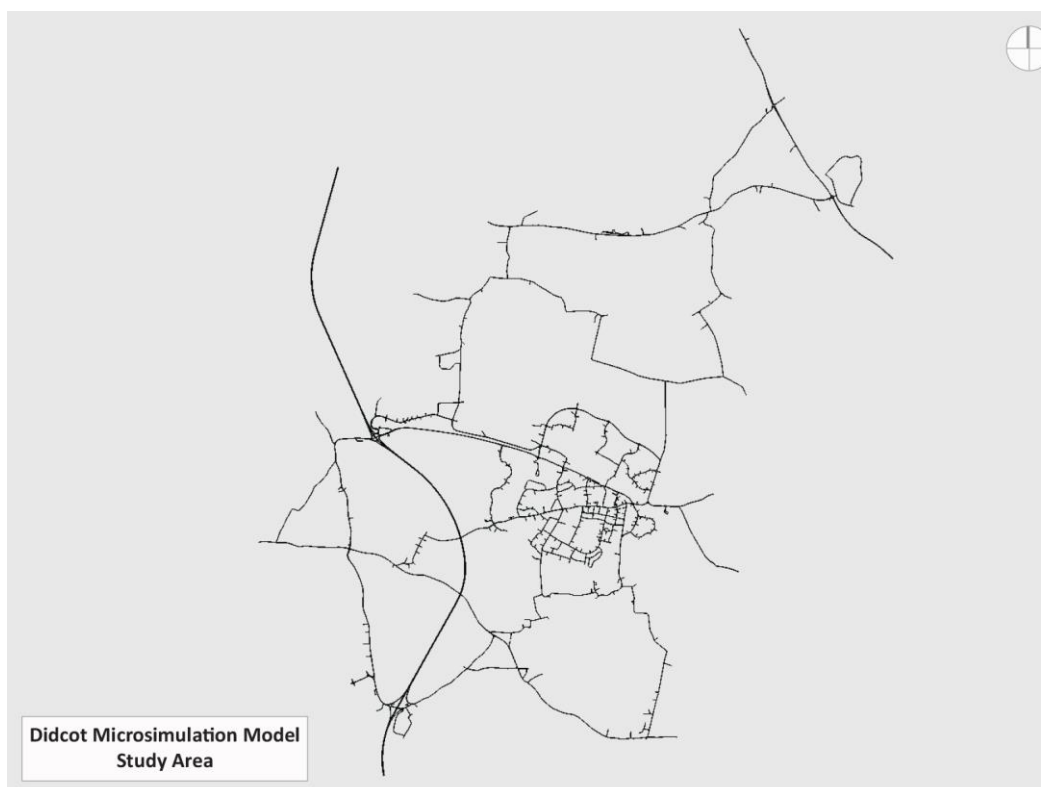
Figure 2.1 : Study Area

The model area extends from the A417 East of East Hendred in the west, through to A4130 Hadden Hill in the East. The network includes the A34 (Chilton Through to Milton Interchange), and up to A4074 Golden Balls Roundabout in the North.

The study area is shown in Figure 2.1 below.

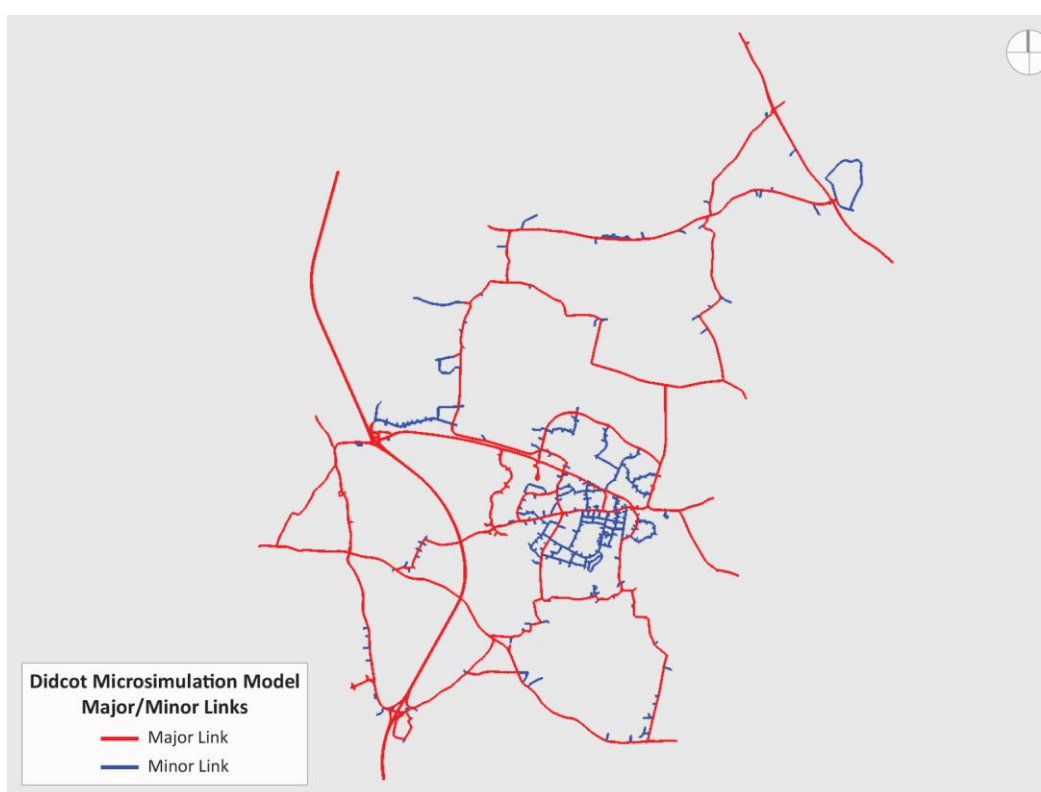
Figure 3.1 : Major/Minor Hierarchy

Major and Minor links are used in Paramics to influence vehicle route choice. All strategic links in the study area (A and B roads and main thoroughfares) were coded as Major links. All other roads (such as side roads or residential roads within towns) have been coded as Minor. The Major and Minor links are shown in Figure 3.1 below.

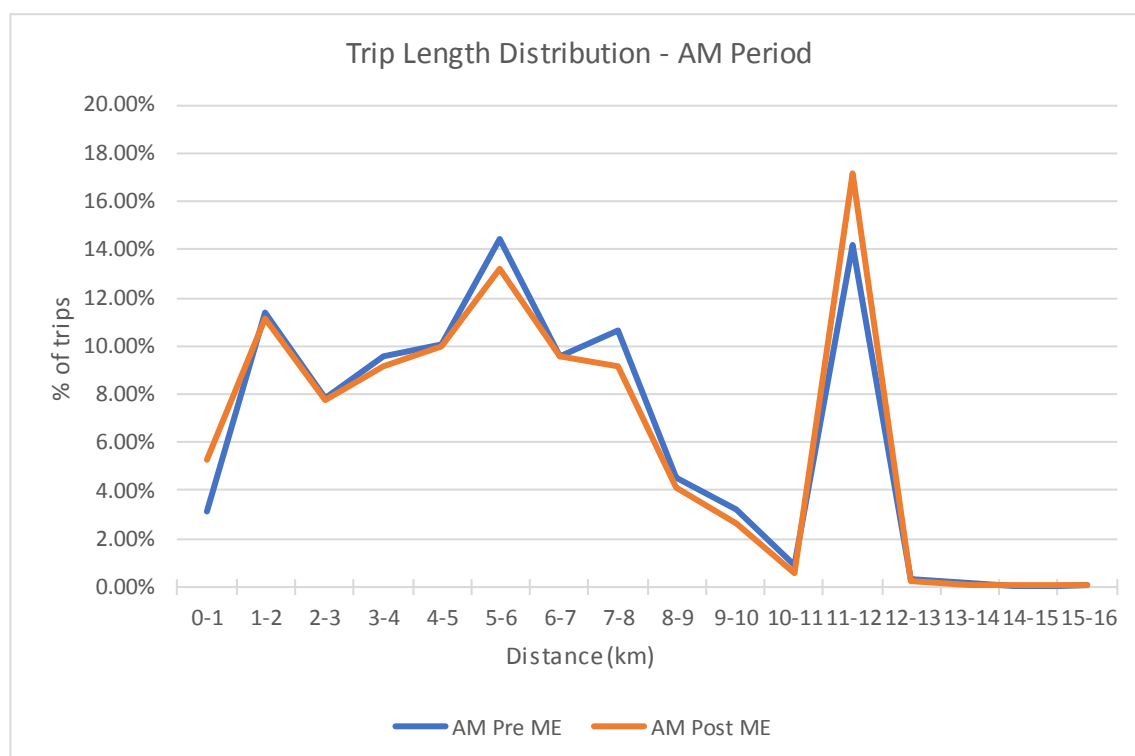
Figure 4.1 : AM Period Trip Length Distribution

Checks were undertaken to ensure that the ME process did not change the overall “shape” of the prior matrix. Figure 4.1 to Figure 4.4 show the percentage of trips within each distance segment, for both pre and Post ME, for each period.

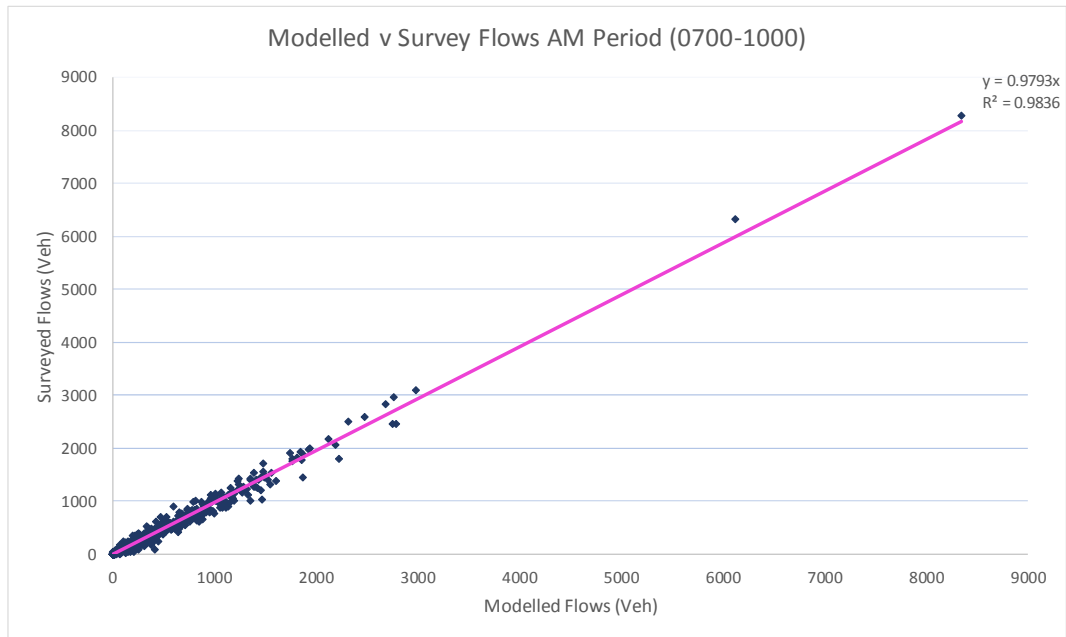
Figure 5.1 : AM Period XY Scatter Plot, Observed v Modelled

With this in mind, the level of calibration achieved and presented within this document for a network the size and scale of Didcot is considered high. To further emphasise the suitability of the results, an XY scatter chart of observed flows versus modelled flows was developed for each modelled period. The XY scatter plot provides a good way of presenting the variation in data in a pictorial format, illustrating the relationship between the observed flows and assigned flows in the model. The correlation coefficient (R) gives some measure of the goodness of model fit, and the slope of the best-fit regression line through the origin indicates the extent to which modelled values are over or under estimated. Acceptability values of R are above 0.95 and the line of best fit should be between 0.9 and 1.1 as stated in DMRB (*Ref. Vol 12, Section 2, Part 1, Chapter 4, §4.4.42*).

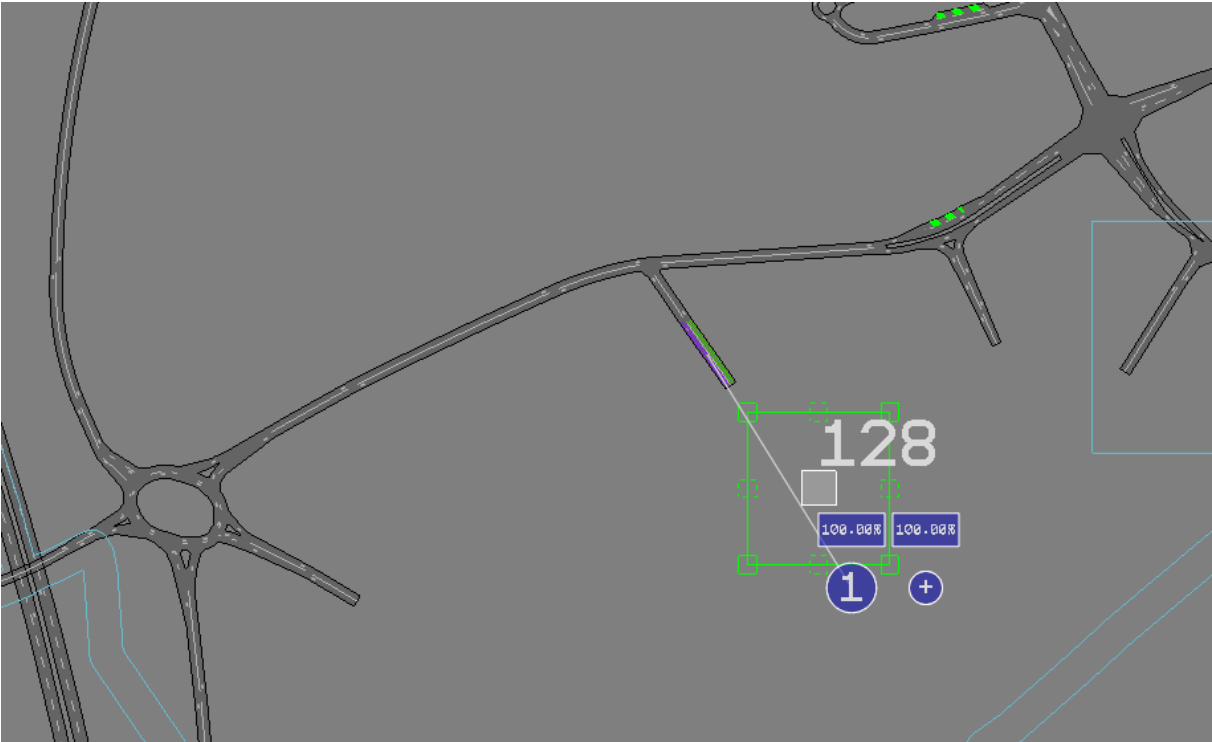
Figure 14. Long Reach Access

Development trips access the model network at a simple T-junction on Didcot Road B4493 approximately 180m west of Keats Drive. See Figure 14.

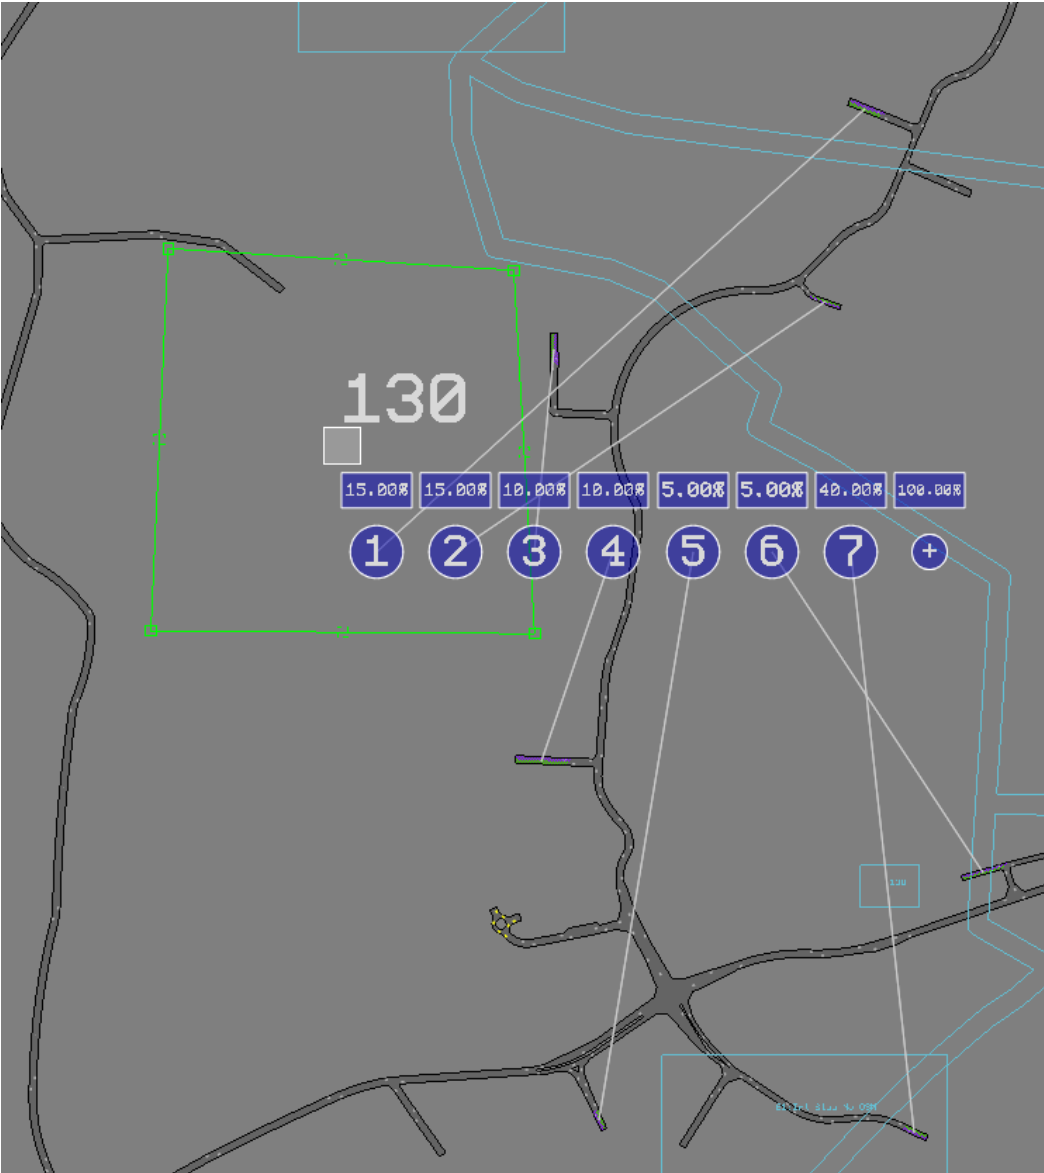
Figure 16. Land at Didcot Road, Great Western Park Accesses

Development trips access the model network at 7 locations with the trips being split on a percentage basis. This zone is associated with the trips within the VoWHDC boundary (see Zone 161 for SODC). The percentages and locations are shown in Figure 16.

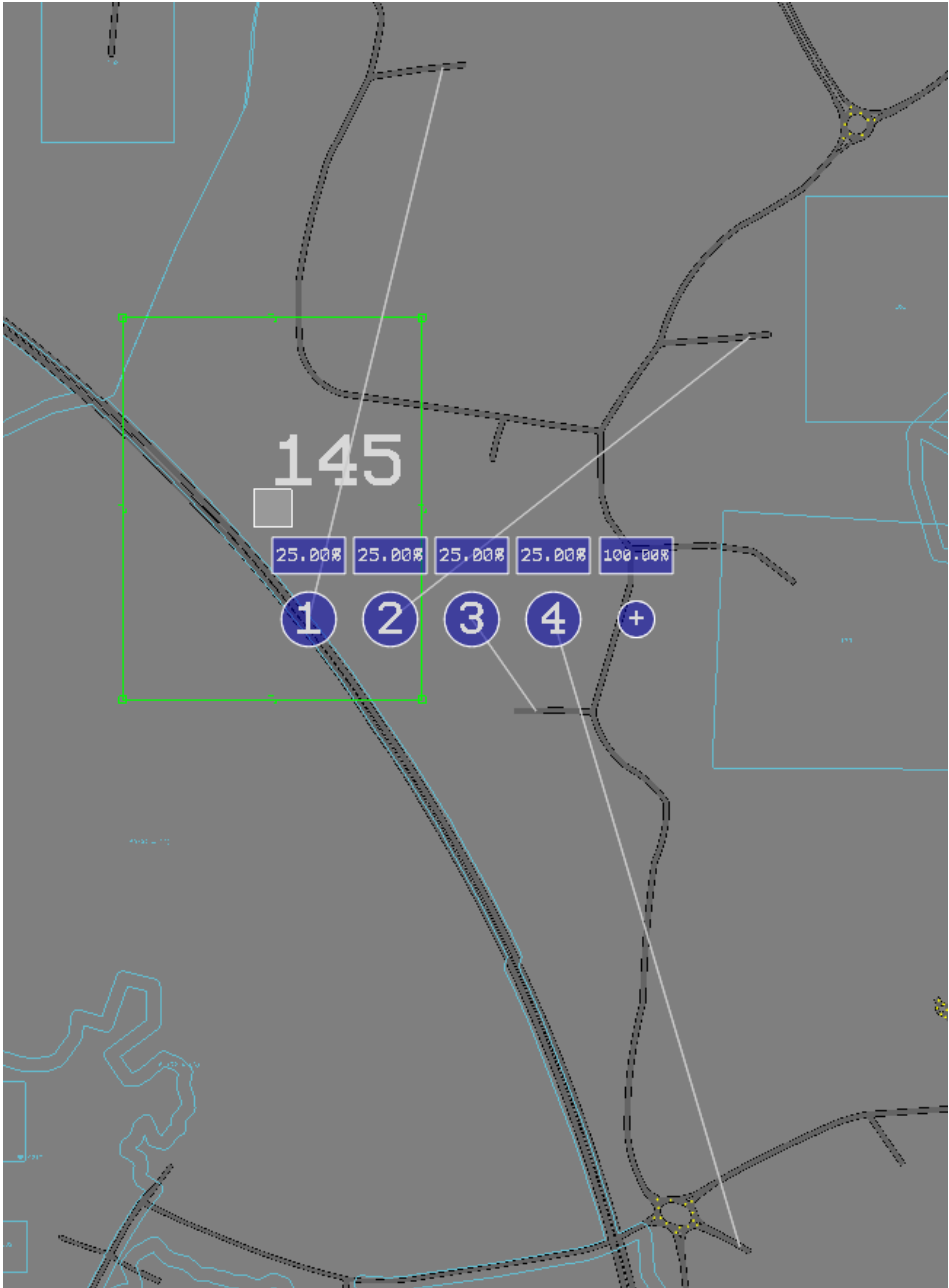
Figure 23. Land to the West of Great Western Park Accesses

Development trips access the model network at 4 locations with the trips being split evenly between each access. The three northern accesses are simple T-junctions off Valley Park Spine Road and the southern access is on to the Harwell Link Road Roundabout. The percentages and locations are shown in Figure 23.

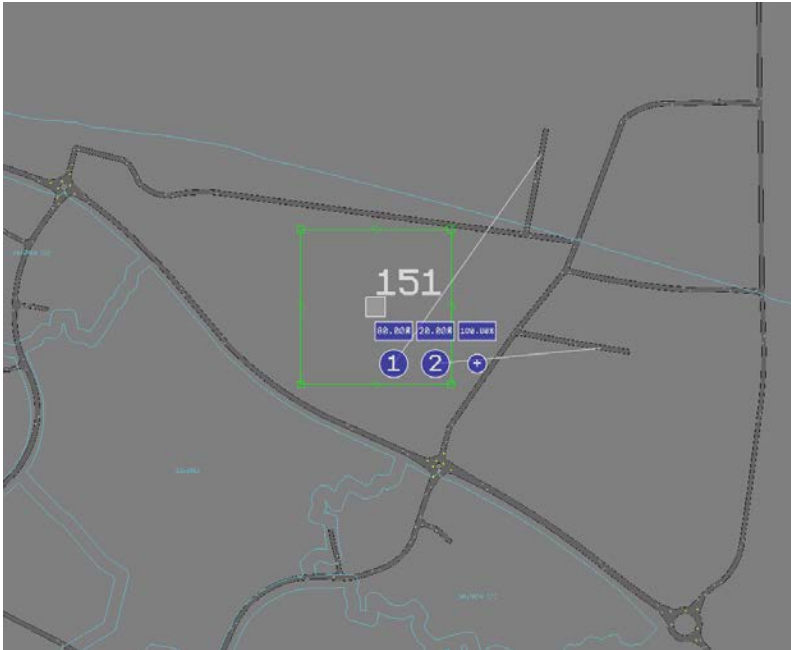
Figure 30. Land to the north east of Didcot Accesses

The development trips access the network split evenly between two locations that form part of an internal development network. The development network joins with the main network at four locations, two priority junctions with B4016 Lady Grove and at the Mersey Way and Avon Way roundabouts on the A4130 as shown in Figure 30.

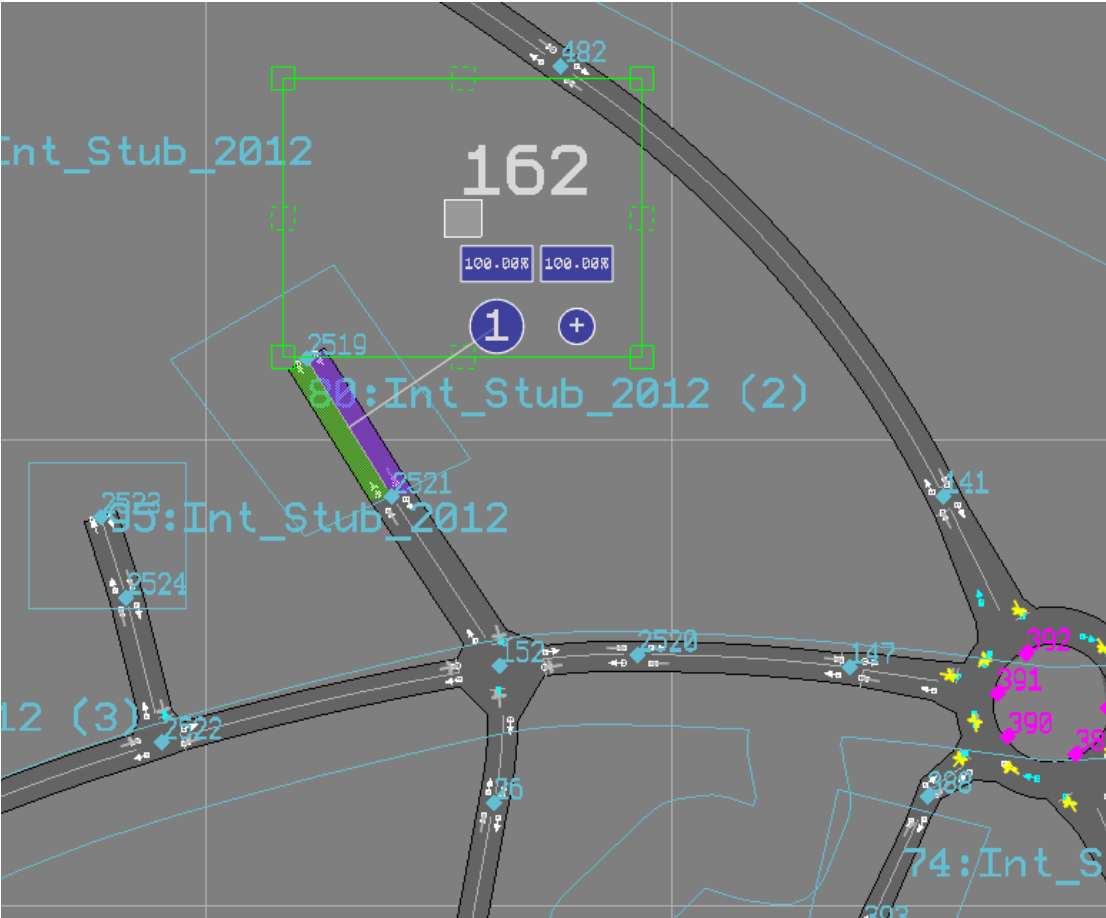
Figure 42. Orchard Centre Phase 2 Access

The development trips access the network at the four arm junction between Broadway and Hagbourne Road using the northern arm of the junction. This is shown Figure 42.

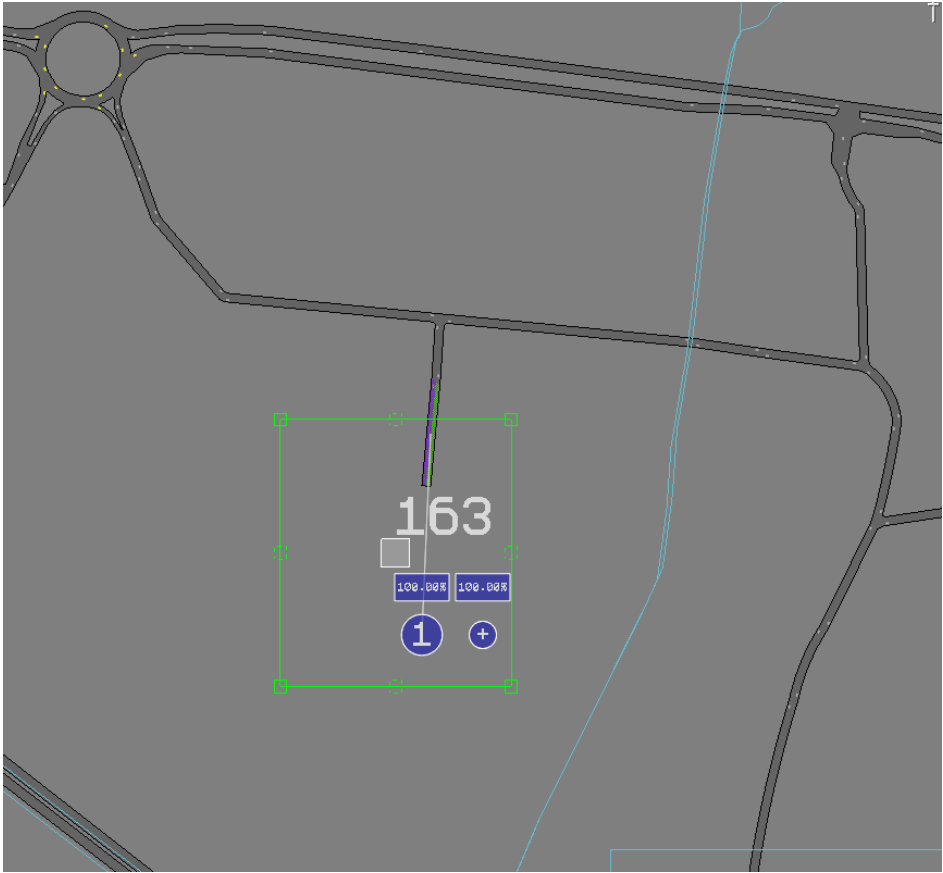
Figure 43. North West Valley Park Accesses with HIF

In the models with HIF infrastructure in place, the development trips access on to an internal development spine road linking the south east arm of the roundabout on the A4130 to a simple T-Junction with Valley Park Spine Road. Vehicles are barred from using the access road as a through route. See Figure 43.

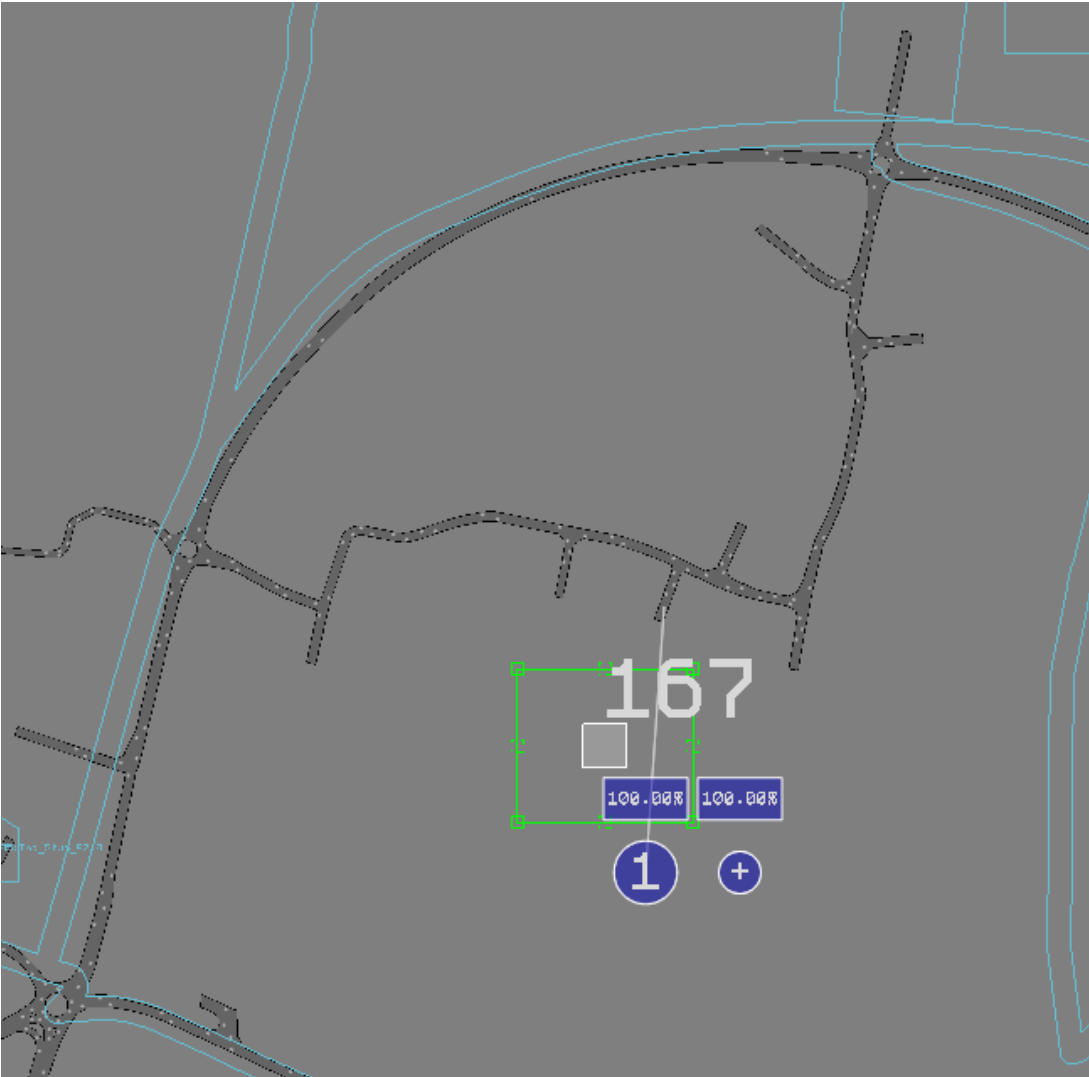
Figure 47. Southmead Industrial Estate

Development trips access the network at a simple T-junction on Hawksworth, approximately 100m west of Collett. See Figure 47.

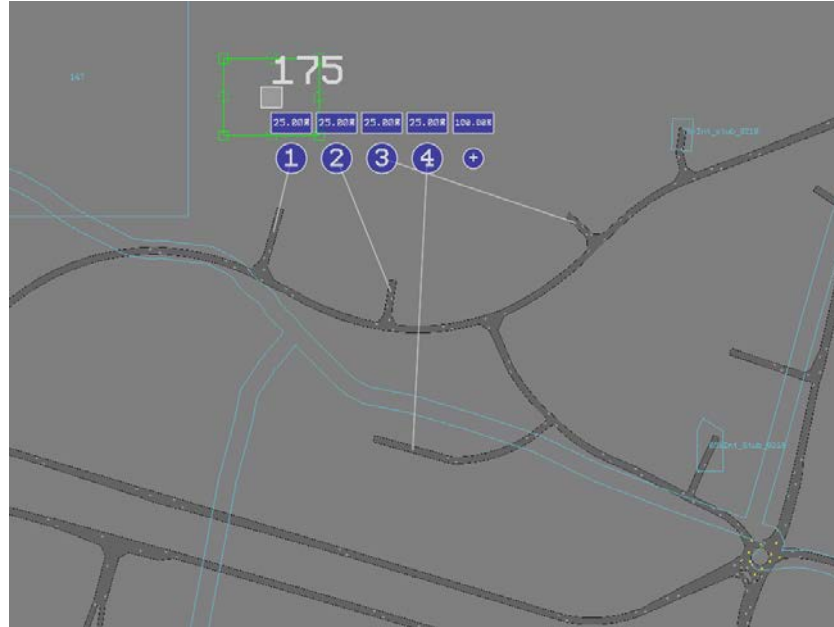
Figure 56. Didcot A Accesses with HIF

With the HIF infrastructure in place, the development trips access the network split evenly between 4 accesses. Three simple T-Junction accesses on to Science Bridge and one access on to an internal development spine road which links Milton Road and the Power Station Roundabout. The development spine road links on to the Science Bridge scheme at a T-junction with a ghost island right turn from Milton Road and can be used as a through route by traffic, as shown in Figure 56.
