OXFORD UNIVERSITY HOSPITALS NHS FOUNDATION TRUST

Horton Hospital Condition Survey

Ref: R/1986.02
March 2017

GKK Transformation

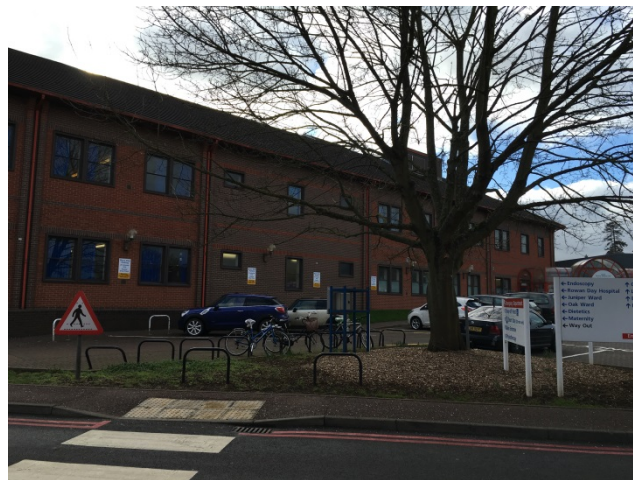
Medical Block (GIA-4566m²)

The Medical block is nearly 30 years old and a significant building on site. The wards are undersized for multiple bedded areas compared to modern space standards (HBN 04). The four bedded bays are tight on space and management of patients is compromised by this. An investment need of just over a £1 million investment need has been identified by this survey.
