Green Road, Oxfordshire

Date of survey	8 June 2026
Surveyor's name	Matt Judson
Surveyor's position	GLASS Representative for Oxfordshire

Assessment by the Green Lane Association

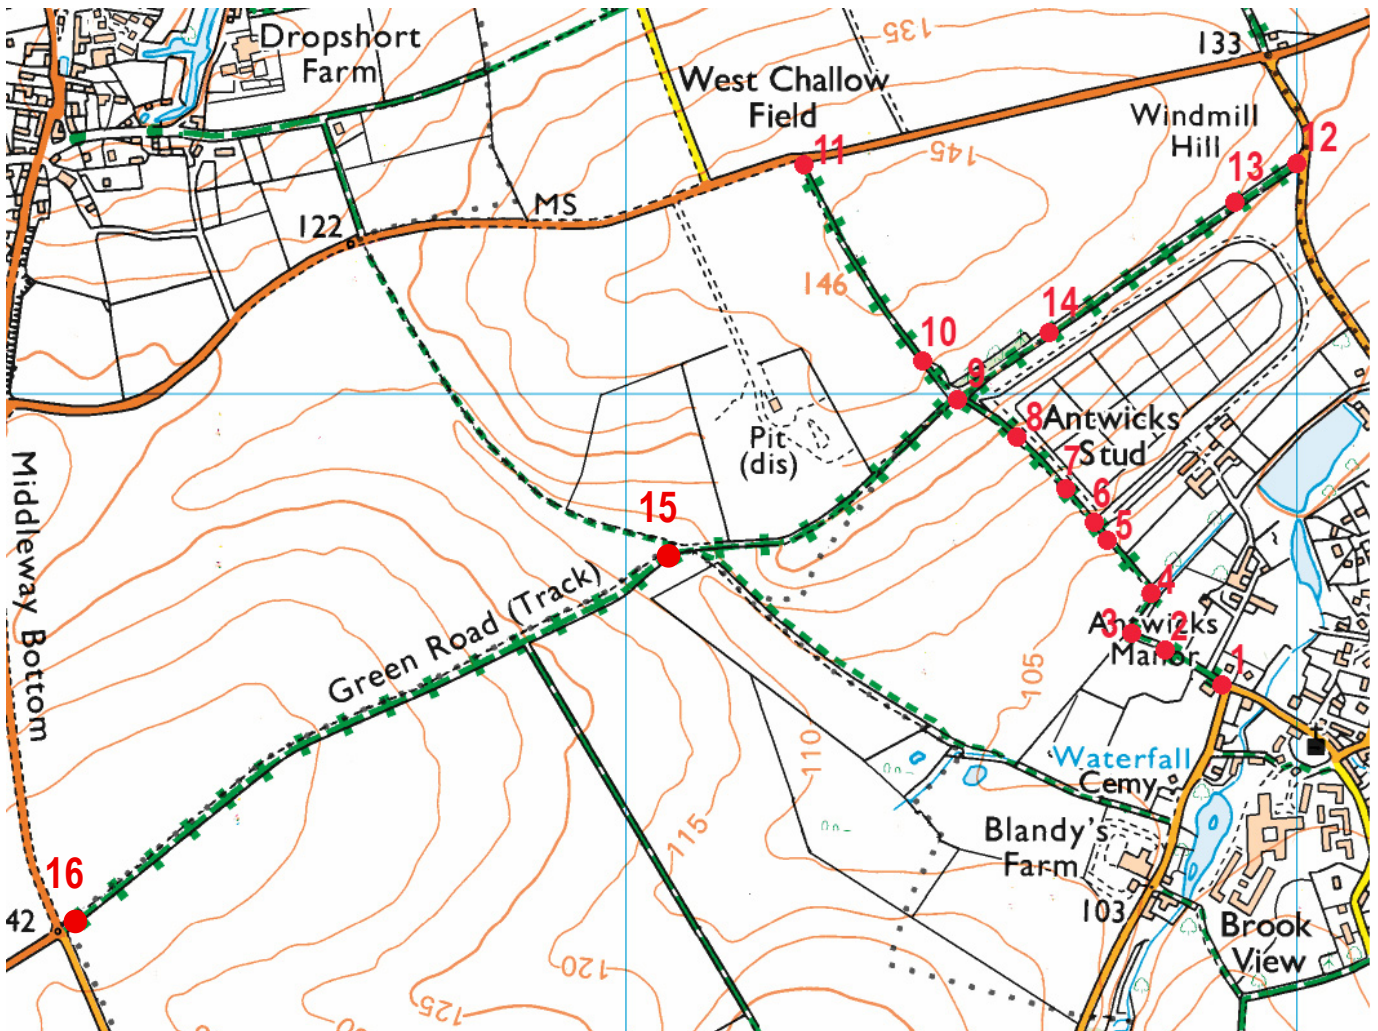
Additional observations	
Width measurements	10m+ throughout, notwithstanding the vegetation encroachment.
Description	<p>The survey was carried from the east starting at Windmill Hill.</p> <p>Overview: This Byway has been the subject of a Temporary TRO since late 2019. There is evidence that during that time some vegetation clearance work has been undertaken, most recently we believe during winter of 2025/2026. Vegetation is already beginning to overcome this clearance work in many places.</p>

The beginning of the Byway, running north of Antwicks Stud, has reduced in width due to vegetation as it passes the disused quarry before opening out at the lowest point (15) where it intersects with a footpath before heading uphill. Towards the highest point, OCC have carried out some levelling work on the surface. The landowner has created a significant ditch to the north of the Byway, presumably to stop users of the Byway using the field.

- The appropriate course is maintenance: improve drainage, add stone where necessary and cut back vegetation.
- Adding drainage and stone to the route in addition to recent repair work would provide a more sustainable and long-term solution and does not need to be costly, particularly when done in collaboration with user groups such as Green Lane Association.
