Letcombe Regis/West Challow BOAT, Oxfordshire

Date of survey	8 June 2026
Surveyor's name	Matt Judson
Surveyor's position	GLASS Representative for Oxfordshire

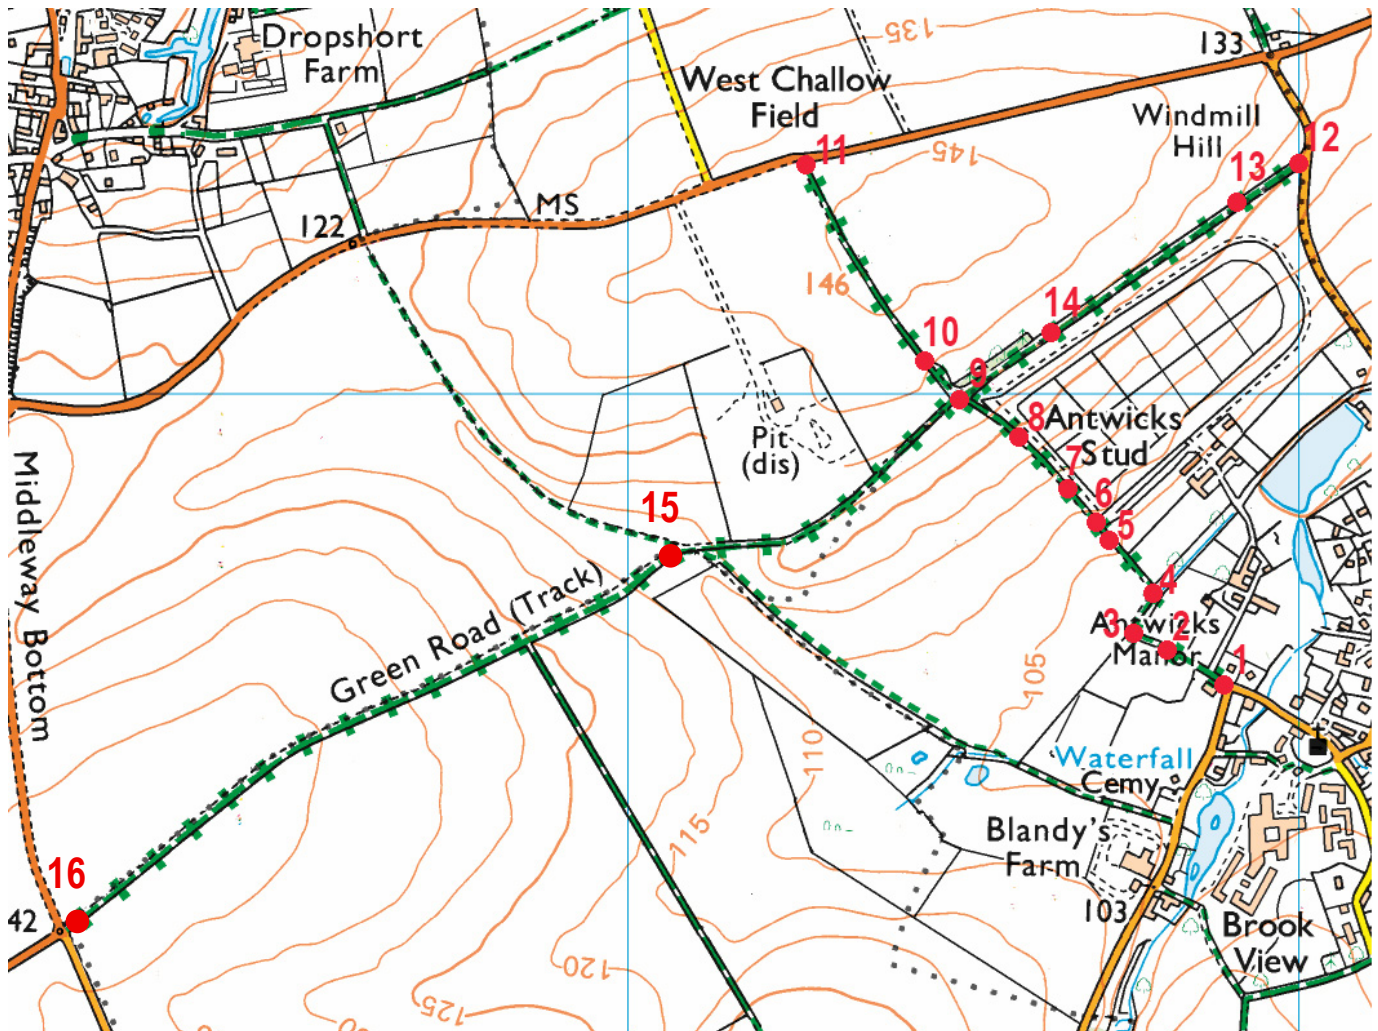
Surveyor's notes:

Width measurements showing the narrowest points	Point 5: 7m Point 7: 6m (made up of 2m road & 6m path) Point 8: 10m Point 10: 7.5m
---	---

Description	<p>The survey was carried from the south, starting at Letcombe Regis Village Hall.</p> <p>Overview: It should be noted that this byway has been the subject of a Temporary TRO since late 2019 and as such much of the narrowing of the byway by vegetation is due to the lack of use. Clearance work would make this byway accessible to carriages and motor vehicles while still allowing access for pedestrians along the paths that have become established during the near seven years of TTRO.</p> <p>In detail: The beginning of the byway (1) is tarmacked and leads to a residential property, Antwicks Manor and on to Antwicks Stud which the byway runs alongside for much of its length.</p> <p>At the field boundary at point 3, a field gate has been installed effectively blocking the byway to all traffic. There is evidence that walkers and horse riders have past the gate post on the right (heading north). While it would be possible to get a carriage or motor vehicle past there is a drop into a ditch on the right-hand side.</p> <p>After this gate, the route has become established along the field edge with the route of the byway having disappeared under vegetation. At point 4, a corner post from an older fence is still visible in the nettles. At this point the byway turns in a north eastern direction. The byway is banked up, with the fields of Antwicks Stud in excess of a metre below the surface of the byway.</p> <p>At point 5, the byway measures 7m between the fence on the right side and the field edge on the left, not narrow. At point 6, concrete blocks have been placed to block the byway to enforce the TTRO. At this point there is a clear distinction between the pedestrian path that has been well used and a more obvious carriage/motor vehicle route.</p> <p>At point 7, there is a very clear distinction between the carriage/motor vehicle route and the pedestrian one. The full width of the highway here is 6m, made up of a 4m walkway on the left-hand edge and a 2m vehicle route to the right to the fence.</p> <p>At point 8, the byway measures 10m from the fence running alongside Antwicks Stud to the field side of hedging. Again, two clear routes allowing for separation of different user groups.</p>
